Sandvik HLX5D Rebuilt X048240

National Service Department
Service Report

Drill Assessed: HLX5D - X 048240

ROCKDRILL SERVICE REPORT

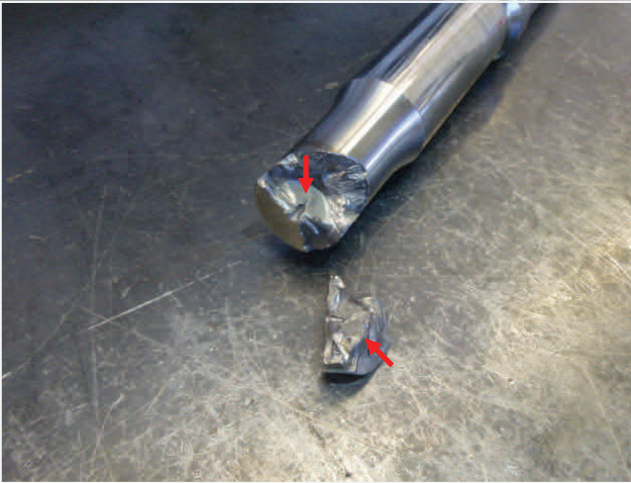
Ph (1) - IB Impact Piston - Replaced - Cracked and damaged.

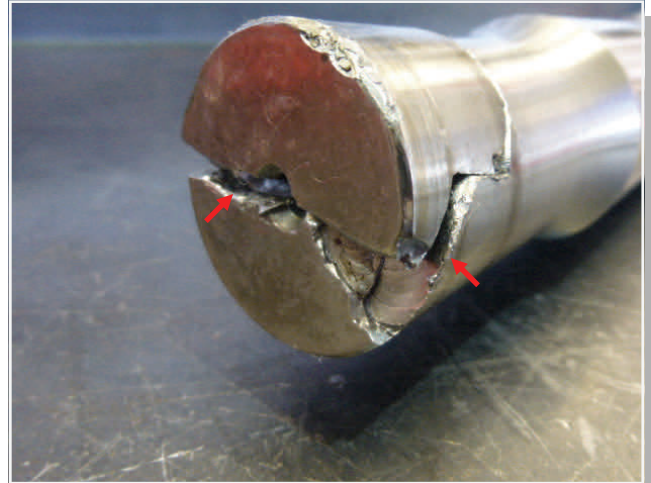
Ph (2) - IB Impact Piston - Replaced - Cracked and damaged.

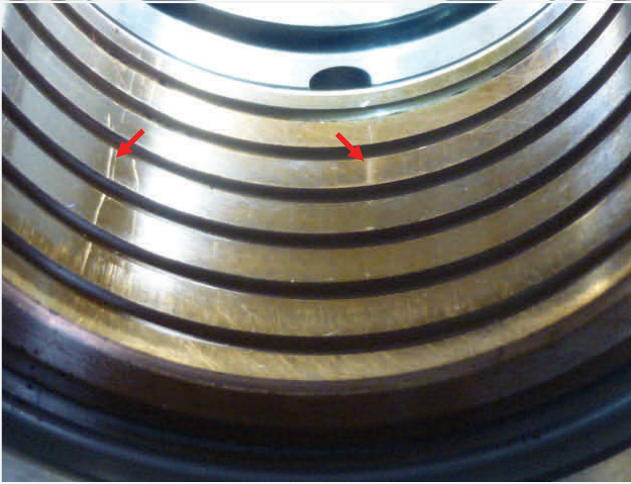
Ph (3) - IB Front Piston Guide - Replaced - Scored - OS1

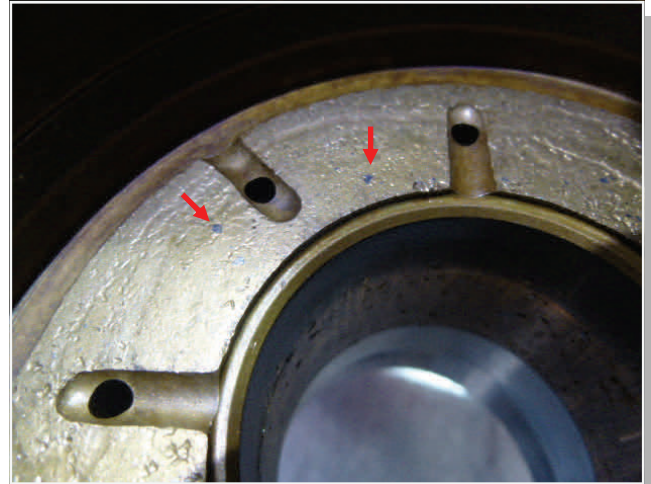
Ph (4) - GH Bearing Bushing (Rear) - Replaced - Damaged and metal contamination.

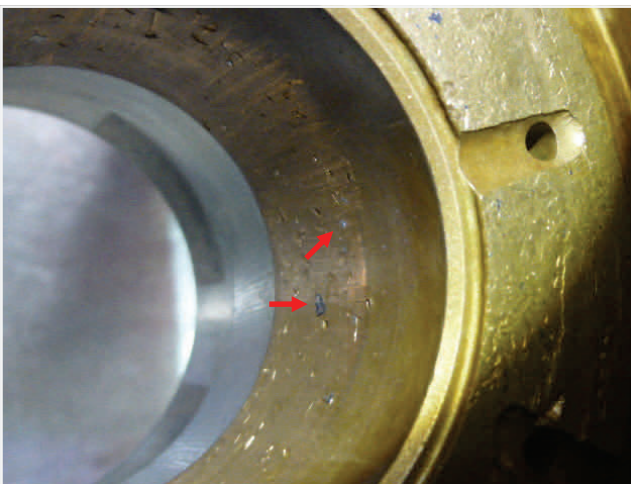
Ph (5) - GH Bearing Bushing (Rear) - Replaced - Damaged and metal contamination.

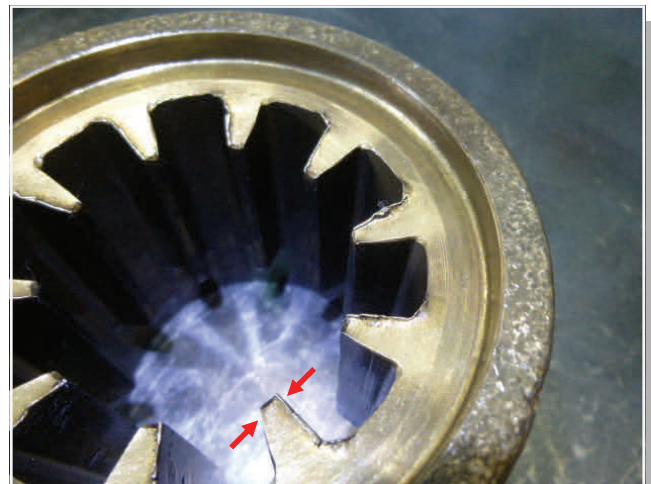
Ph (6) - GH Driver - Replaced - Worn under minimum specification.

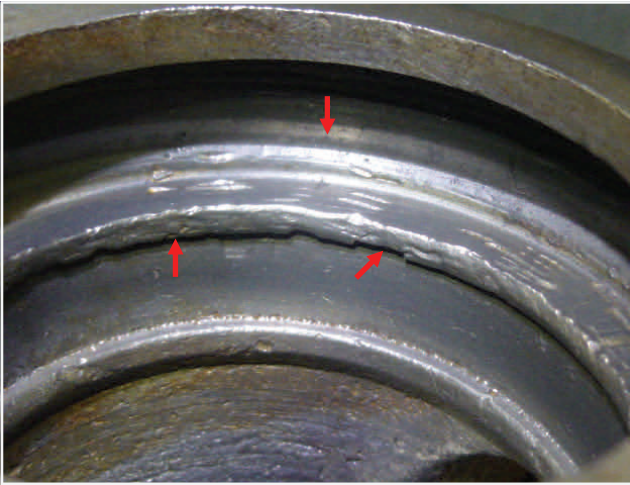
Ph (7) - FH Seal Housing - Replaced - Damaged.

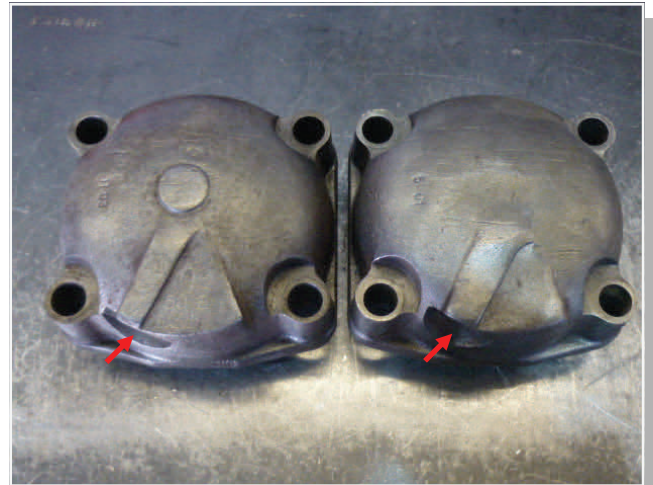
Ph (8) - LP Accumulator - Replaced - Not With Machine - 2x HP supplied - Second Hand in Spec Unit Supplied.

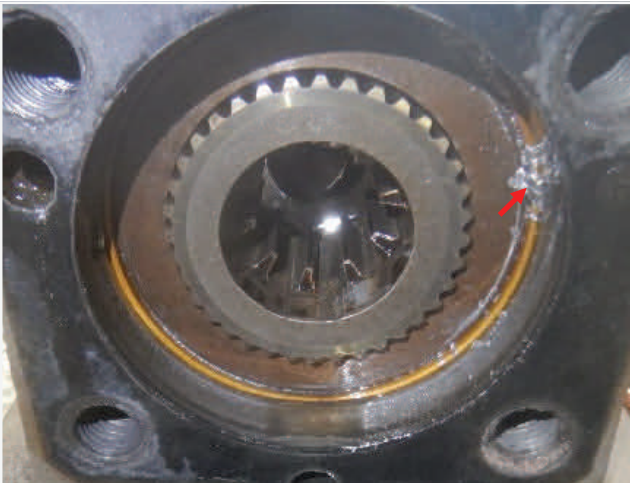
Ph (9) - Gear Box - Reference - Metal contamination.

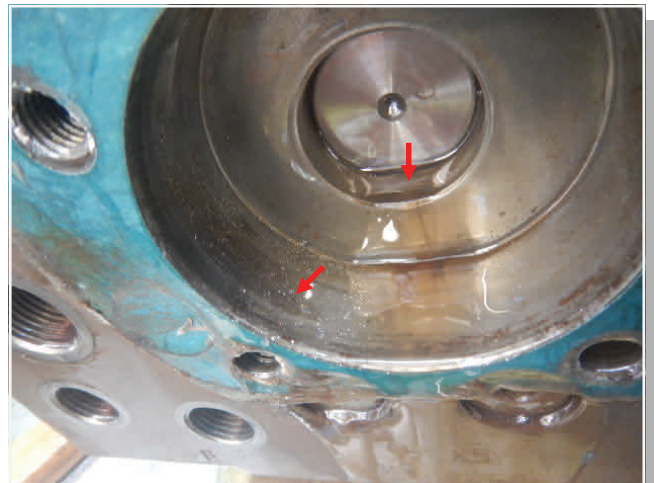
Ph (10) - Impact Body - Reference - Metal contamination and hydraulic oil leaking.

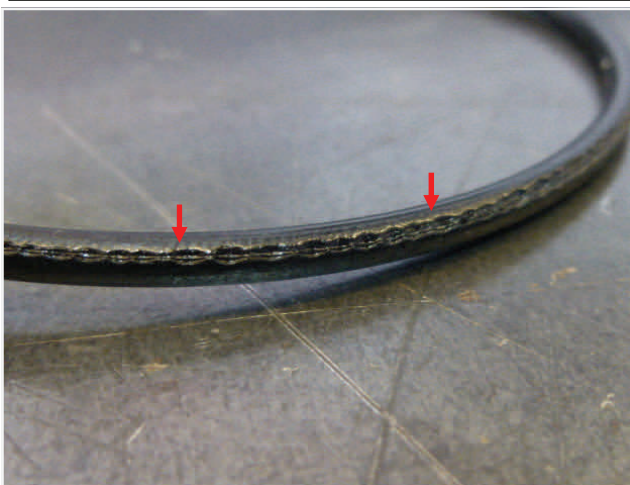
Ph (11) - IB Cylinder O-ring - Reference - Perished.

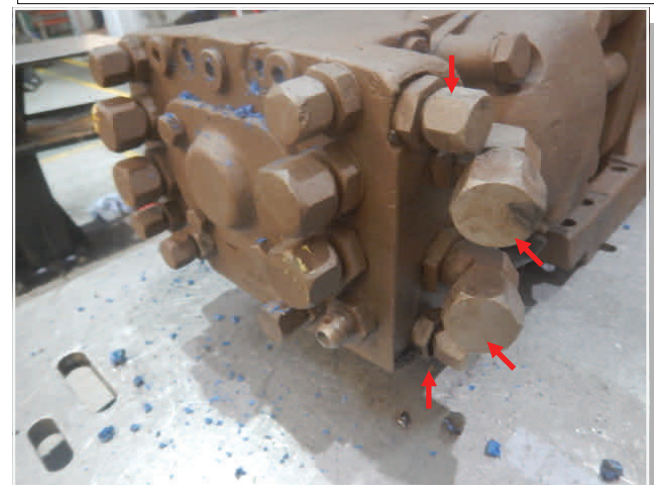
Ph (12) - Impact Body - Reference - Incorrect hydraulic fitting setup - Bypasses Return restrictor.

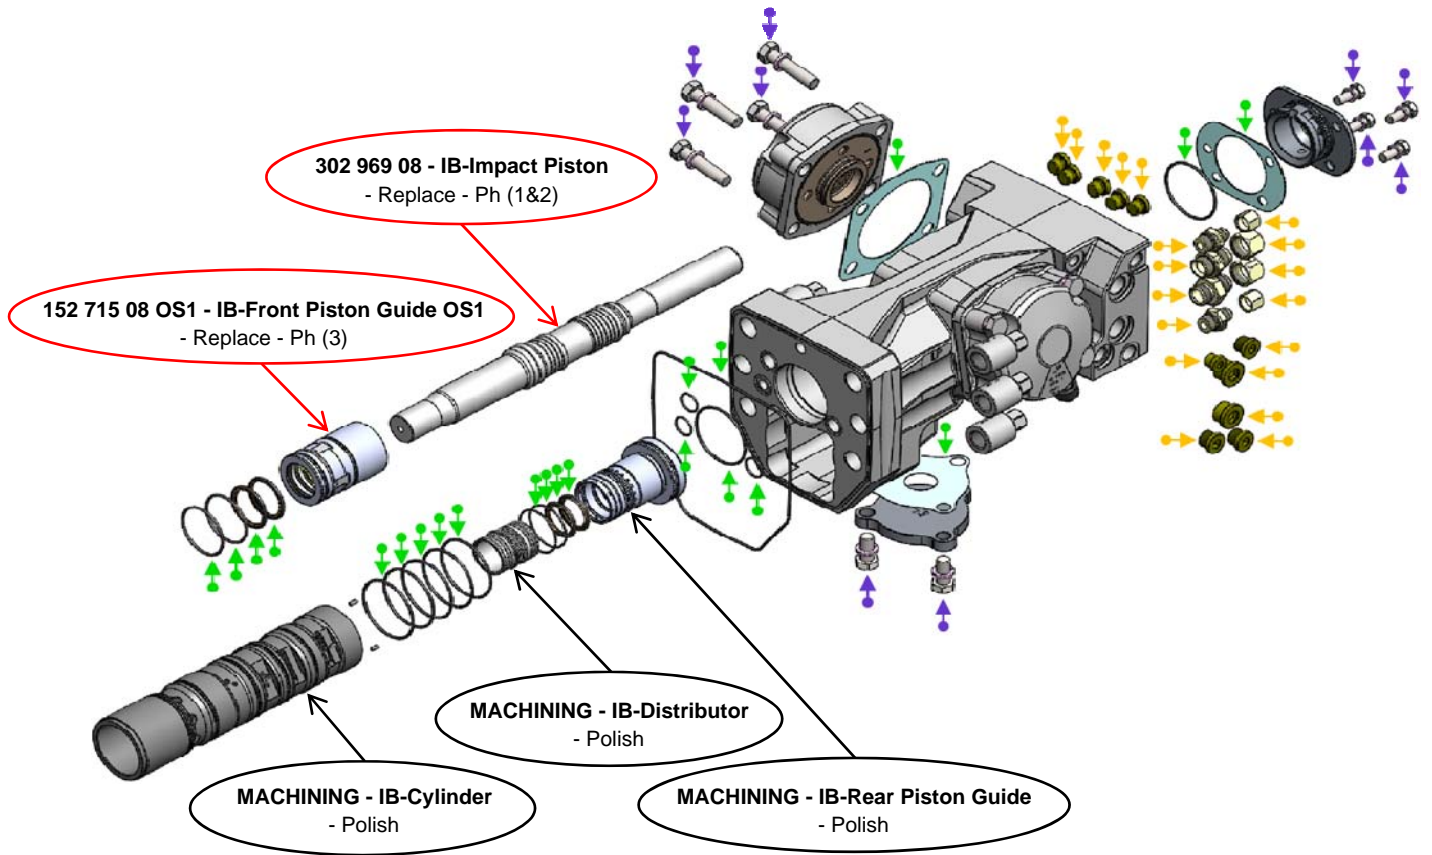
Impact Body Machining and Significant Items Replaced

Impact Body - Tie Rod mating faces skimmed this service - Overall length, bore dimensions, bore condition and fatigue life have been considered when analysing the overall condition of the Impact Body. The current condition is 45% of overall life.

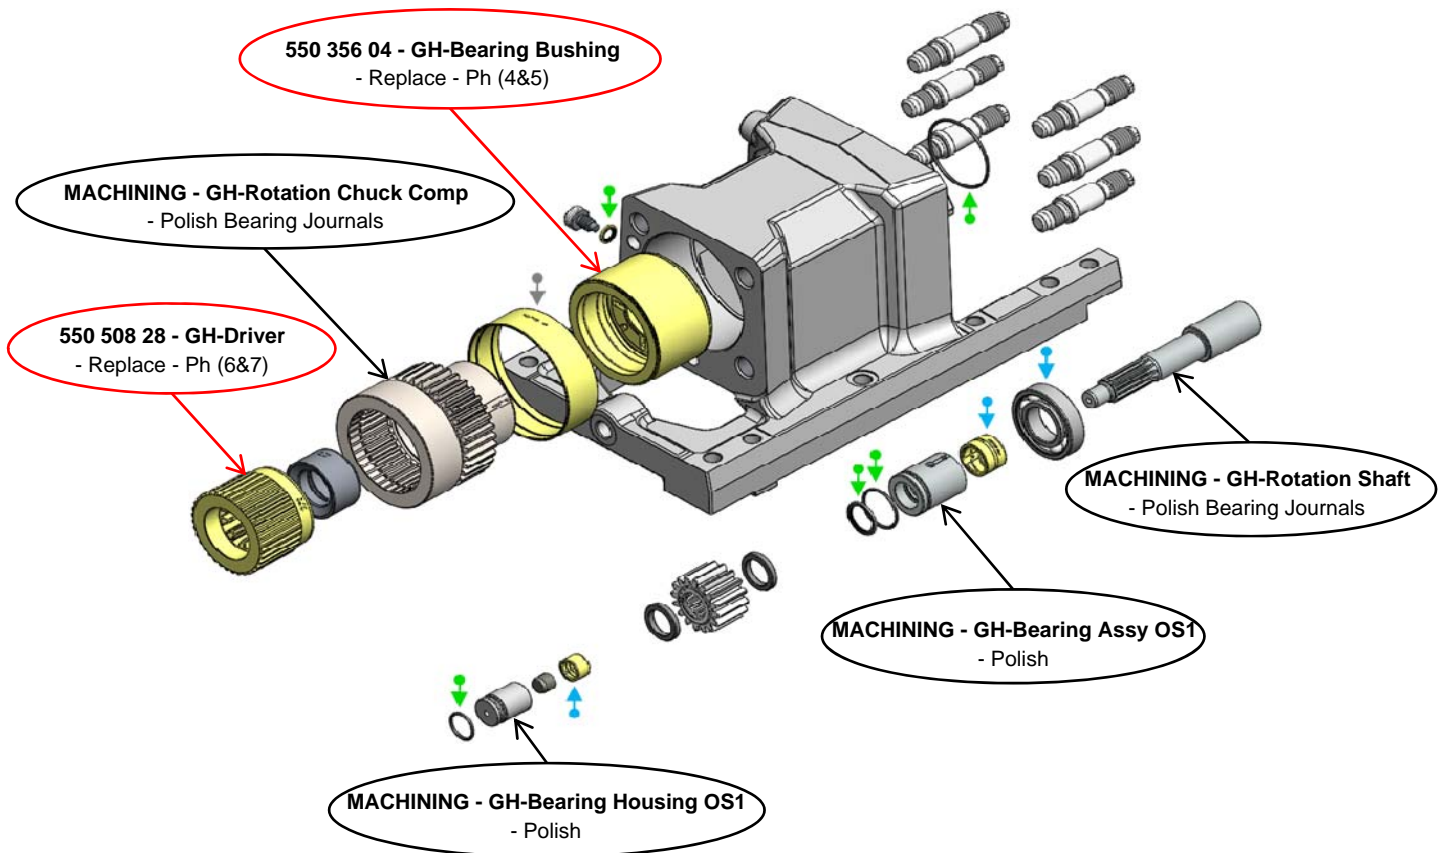
Gear Housing Machining and Significant Items Replaced

Gear Housing - Flushing Head mating face skimmed this service - Overall length, bore dimensions, bore condition and fatigue life have been considered when analysing the overall condition of the Gear Housing. The current condition is 30% of overall life.
