# NIFTY COPPER PTY LTD

## STRIP AND QUOTE HLX5T ROCKDRILL

Customer: NIFTY COPPER PTY LTD      Date: 09/10/2019      Job number: 7396941

Your STRIP AND QUOTE HLX5T ROCKDRILL: **HLX5T KIT**, S/No **R048431** arrived in our Kalgoorlie rebuild centre on the 3/10/2019 with 1033 hours.

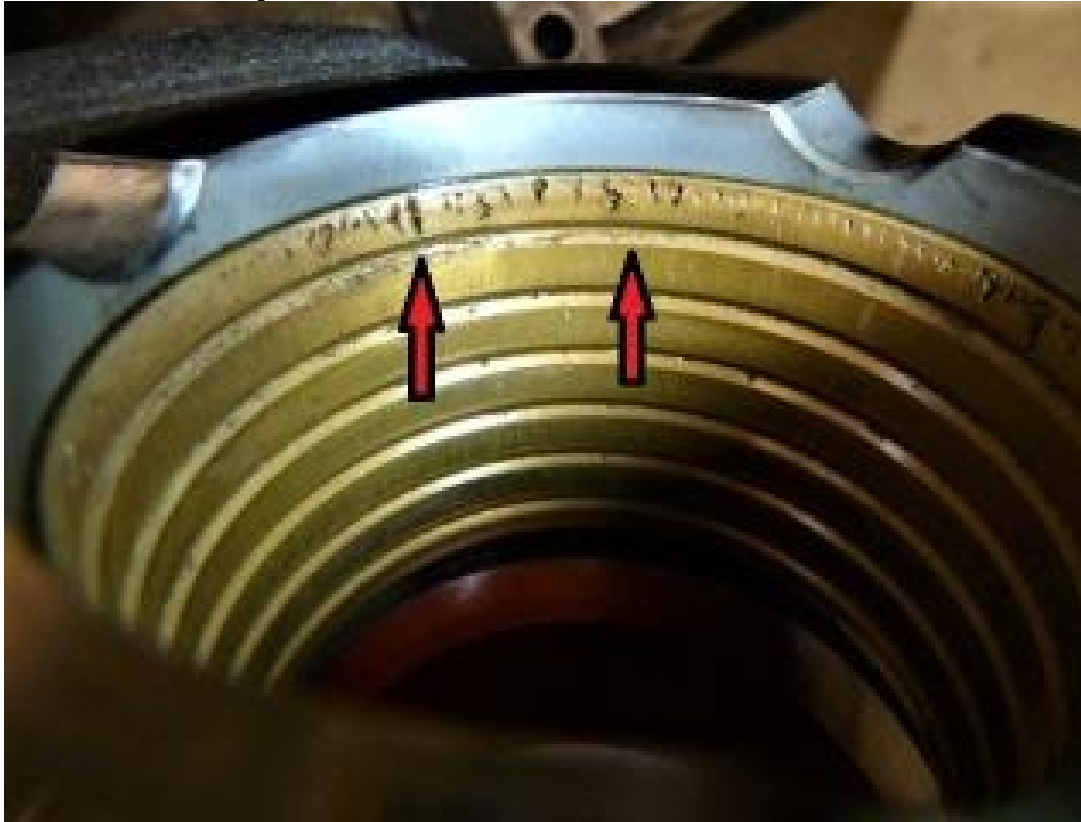
Ref.	Part Description	Qty	Cond. code	Comment
1	BEARING - INC PERCUSSION KIT	1	3	The front bush is starting to crack.

1 The front bush is starting to crack.

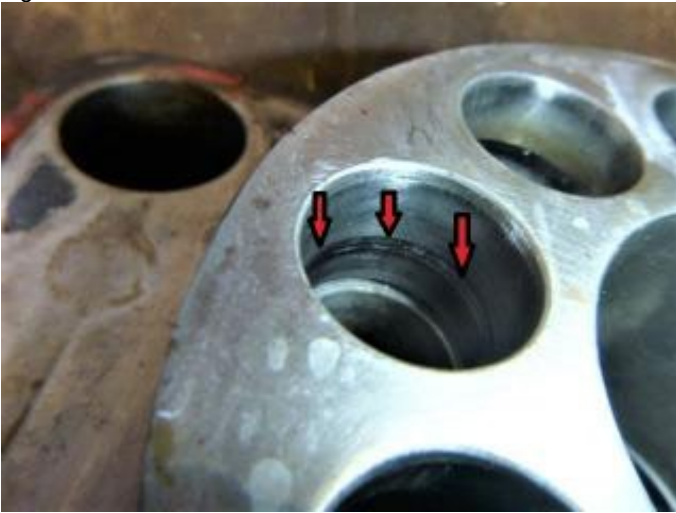
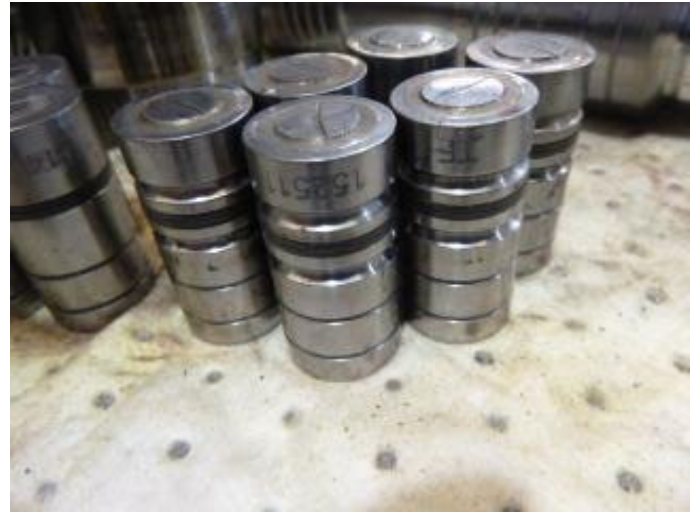
The spacer stabilizer piston bores are worn. Will replace the stabilizer pistons with the alternate type which has the seals locate higher in the bore.

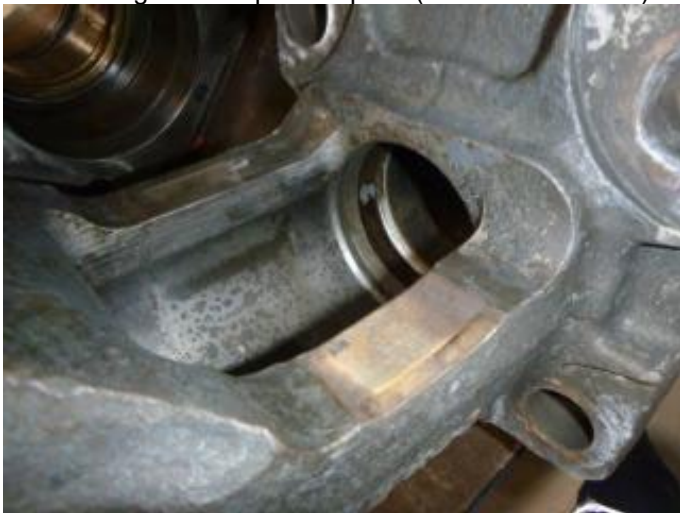
The flushing head requires repairs (build and machine) to the worn seal carrier land to extend its service life

Machining Required: Spacer Body and Flushing head.

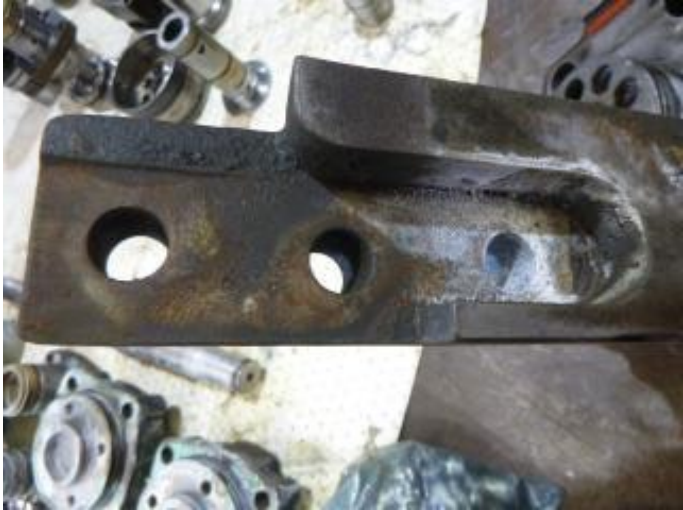
The spacer body mounts are worn and require machining.
