# NIFTY COPPER PTY LTD

## STRIP AND QUOTE HLX5 ROCKDRILL

Customer: NIFTY COPPER PTY LTD Date: 16/07/2019 Job number: 7393736

Your STRIP AND QUOTE HLX5 ROCKDRILL: **HLX5 KIT**, S/No **T048214** arrived in our rebuild centre on the 5/07/2019 with 1019 hours.

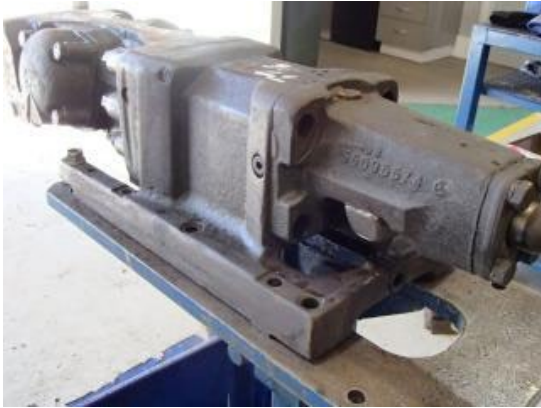
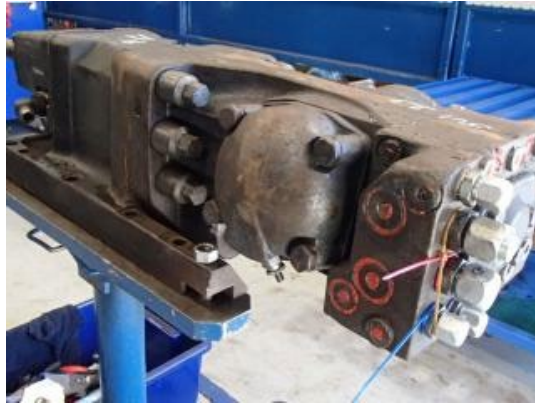
Arrived in a Steel Box. Complete with flushing head, seal carrier and shank.

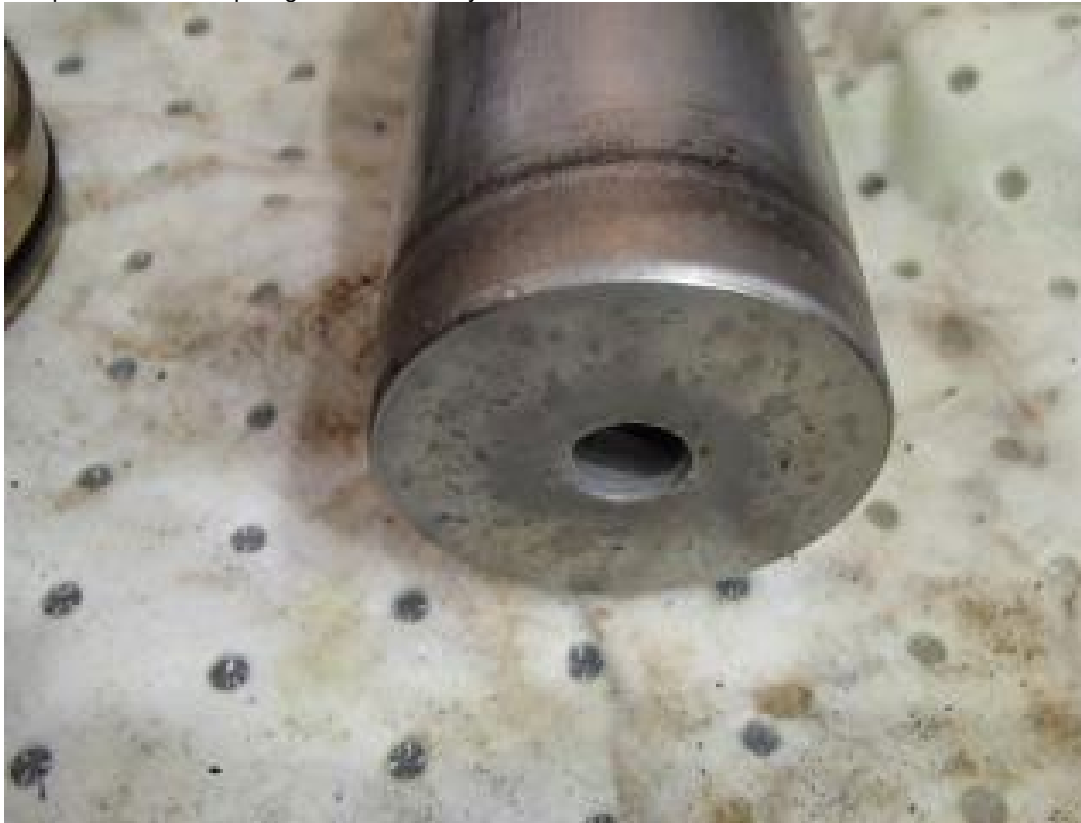
Ref.	Part Description	Qty	Cond. code	Comment
2	PISTON - INC PERCUSSION KIT	1	3	The piston has some pitting and is worn very near to service limit at the striker face.

2 The piston has some pitting and is worn very near to service limit at the striker face.

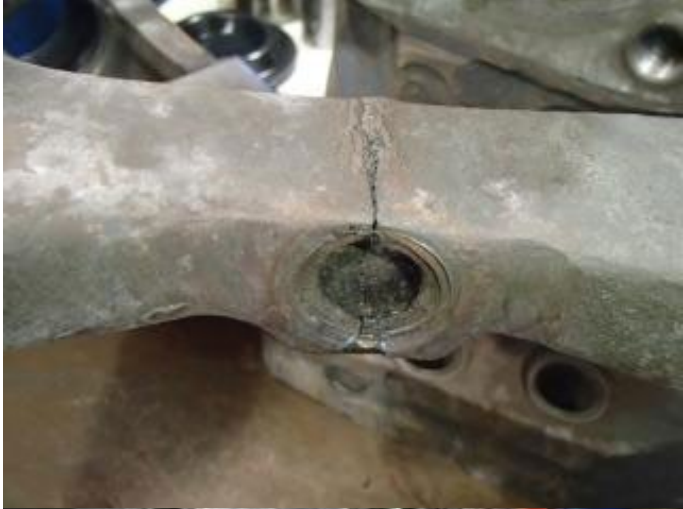
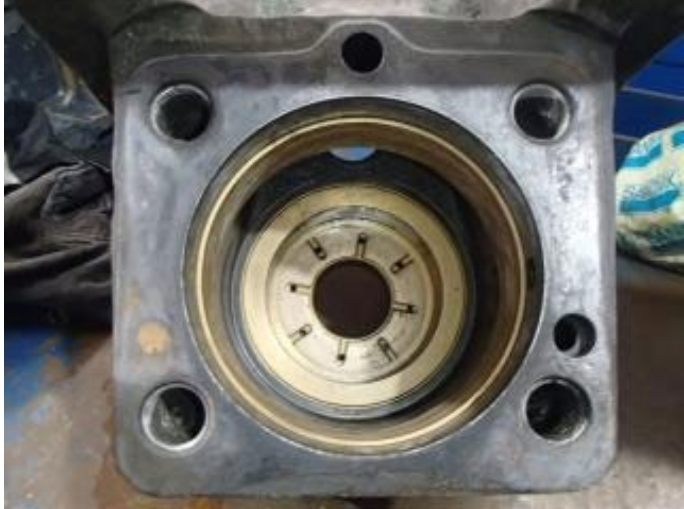
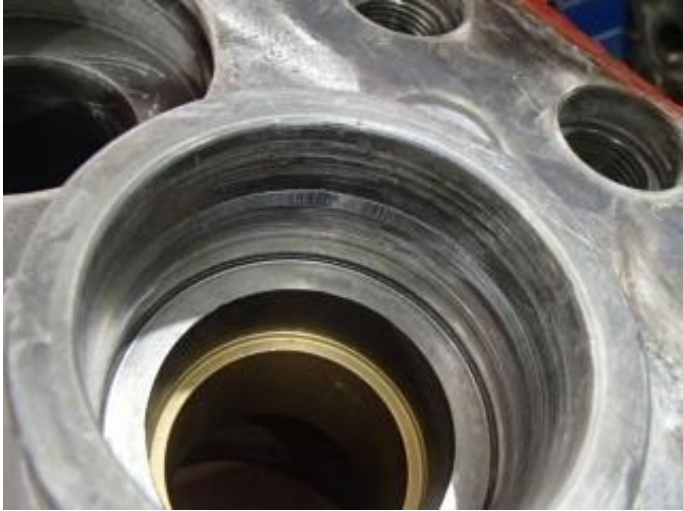
The gear-box requires repairs to the cracked and worn rope mount, skim the front face and resleeve the rear bush bore.

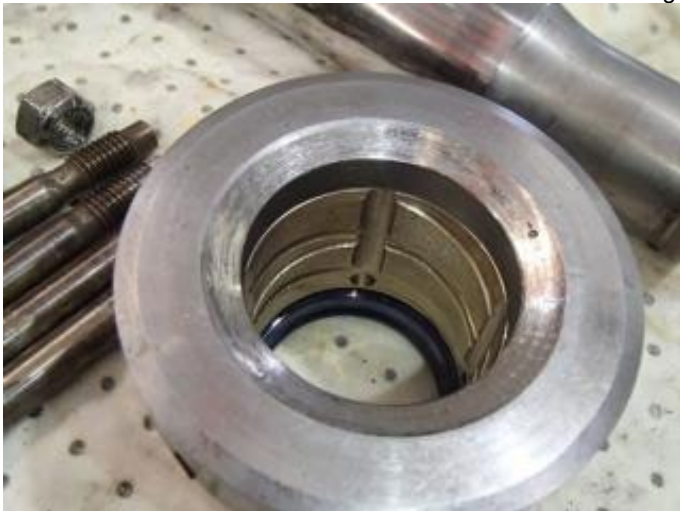
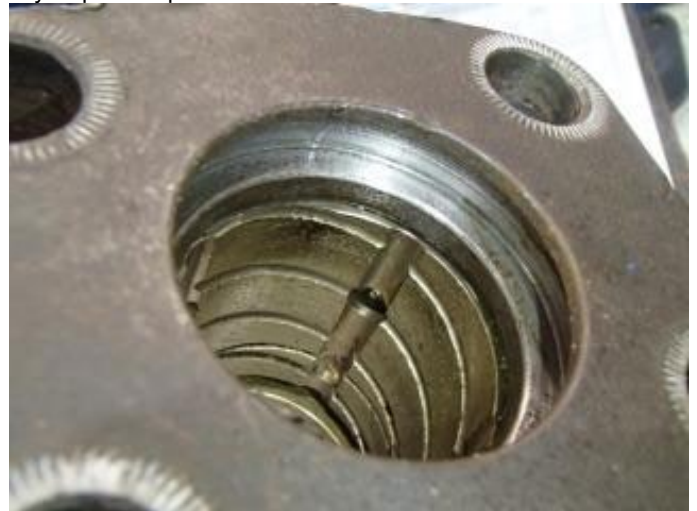
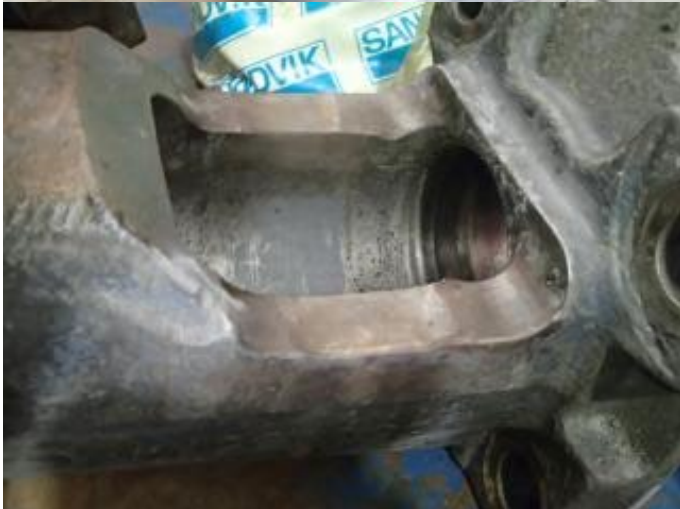
The worn bushes are included in the rebuild kit and the flushing head body requires repair to the worn seal carrier seat.
