Sandvik HLX5D Incomplete N048123

National Service Department
Service Report

Drill Assessed: HLX5D - N048123

Independence (Long Shaft) HLX5D Serial No. N048123 Service Report - Build 1

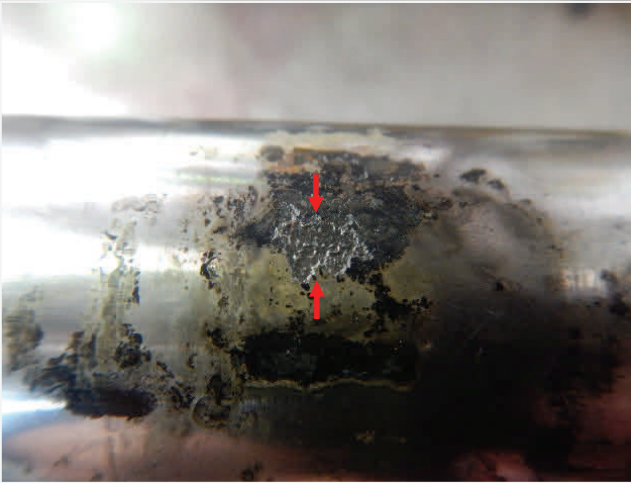
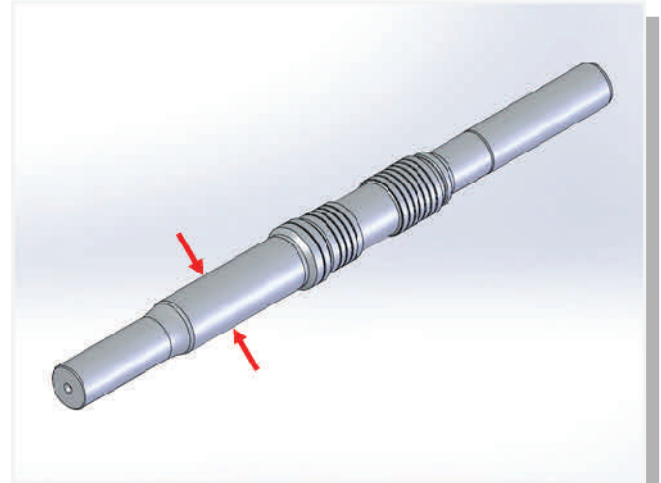
Ph (1) - IB - Impact Piston - Replaced - Deep corrosion on front seal journal.

Ph (2) - IB - Impact Piston - Replaced - Deep corrosion on front seal journal.

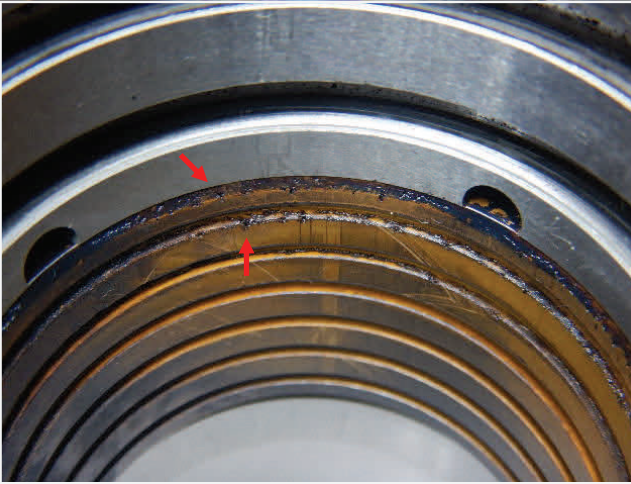
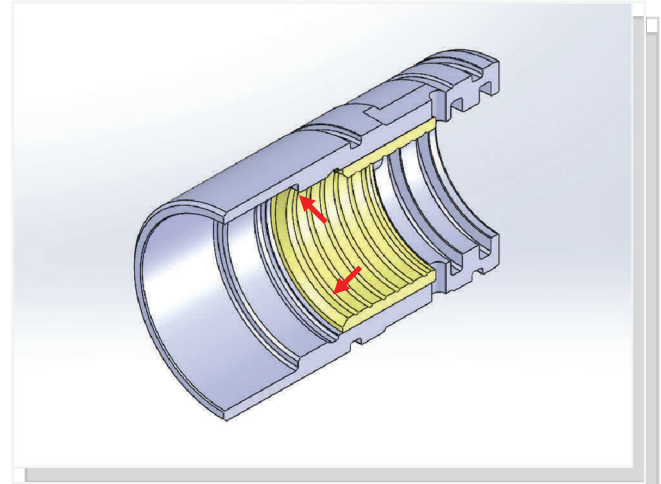
Ph (3) - IB - Front Piston Guide - Replaced - Cavitation on piston guide.

Ph (4) - IB - Front Piston Guide - Replaced - Cavitation on piston guide.

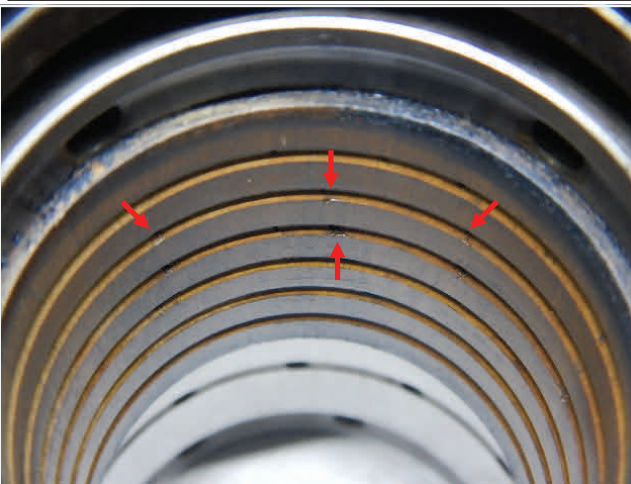
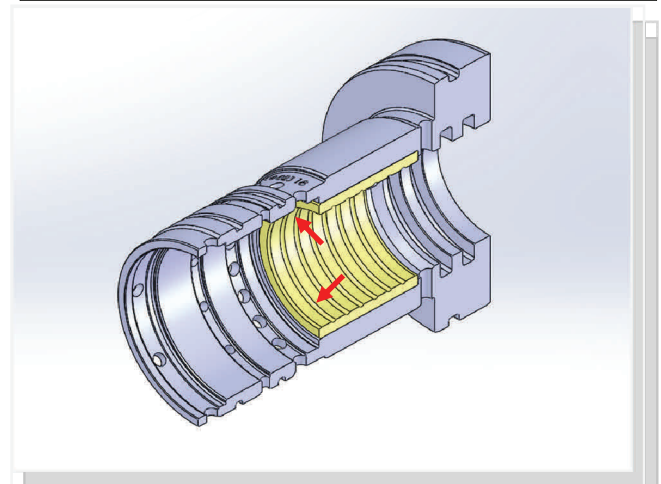
Ph (5) - IB - Rear Piston Guide - Replaced - Cavitation and liner damage.

Ph (6) - IB - Rear Piston Guide - Replaced - Cavitation and liner damage.

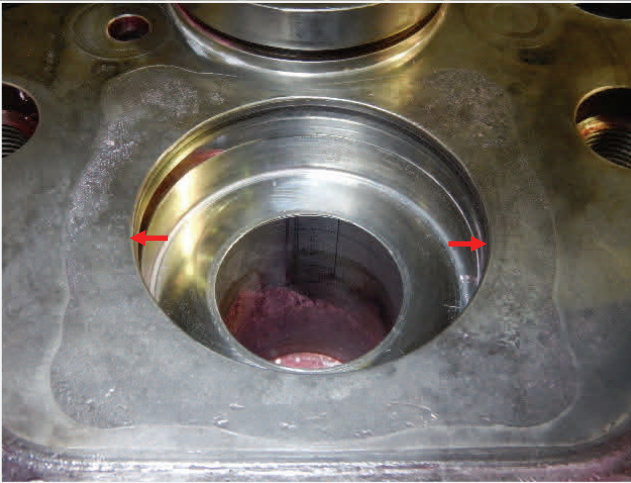
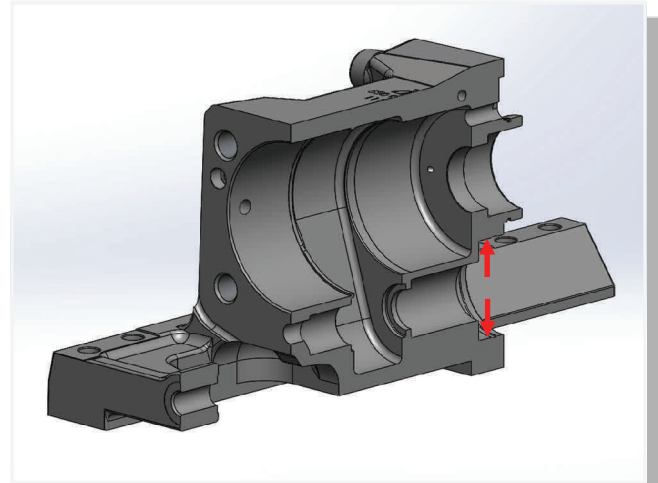
Ph (7) - Gear Housing - Machining - Repair Deep groove ball bearing bore oversize and worn.

Ph (8) - Gear Housing - Machining - Deep groove ball bearing bore oversize and worn. - Repair

Gear Housing - Impact Piston Guide OS2 Mod, Large Ball Bearing Spigot Bore Repairs completed this service - Overall length, bore dimensions, bore condition and fatigue life have been considered when analysing the overall condition of the Gear Housing. The current condition is 40% of overall life.

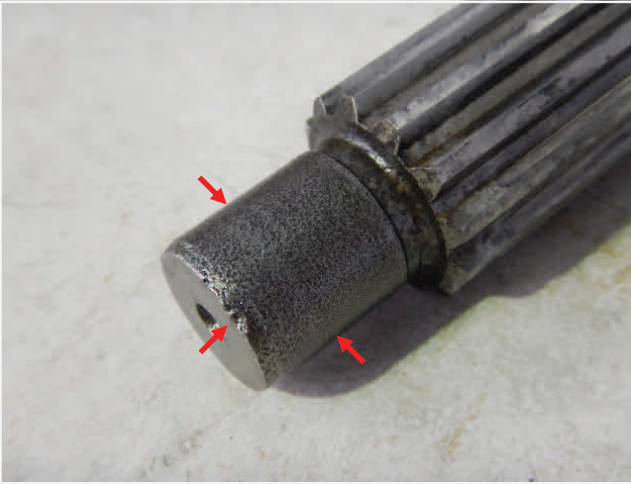
Ph (9) - GH - Rotation Shaft - Replaced - Small bearing journal corroded and damaged.

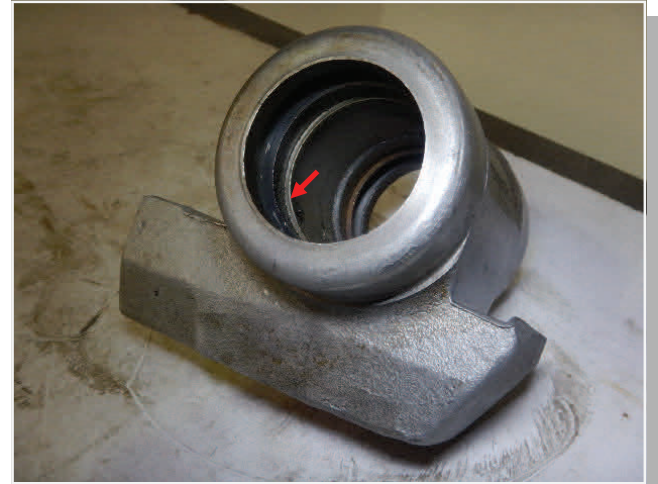
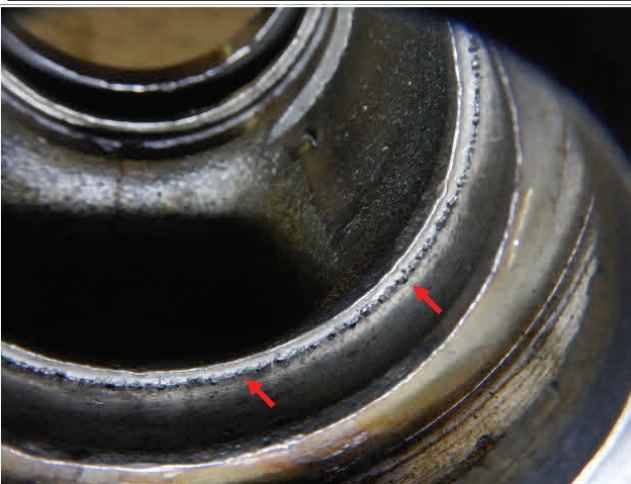
Ph (10) - Seal Housing - Replaced - Seal grooves corroded and damaged.

Ph (11) - Seal Housing - Replaced - Seal grooves corroded and damaged.

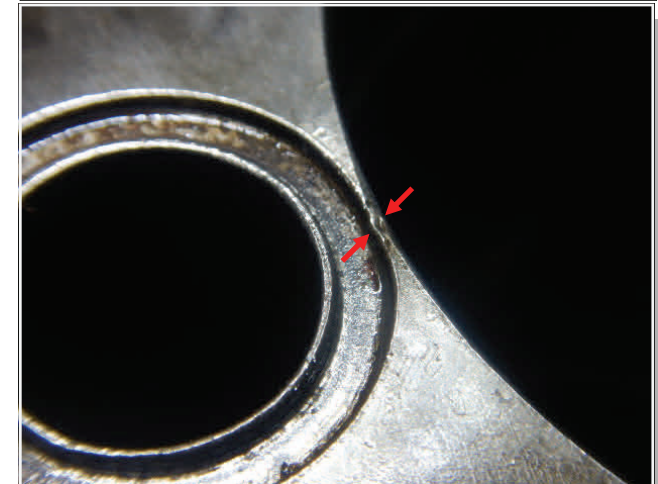
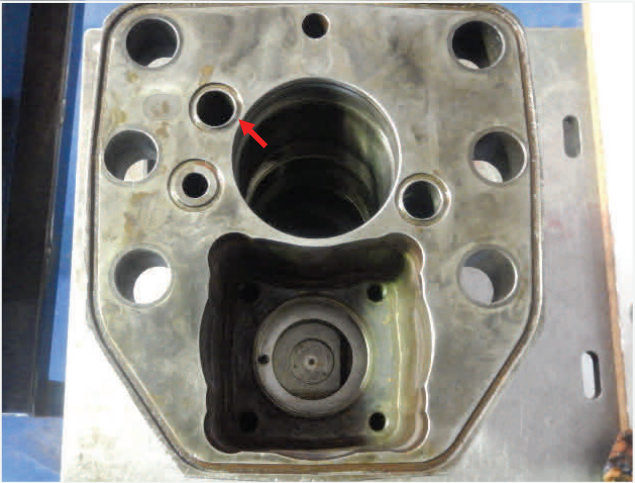
Ph (12) - Impact Body - Machining - Possible weld repair on o-ring seat.

Ph (13) - Impact Body - Reference - Possible weld repair on o-ring seat.

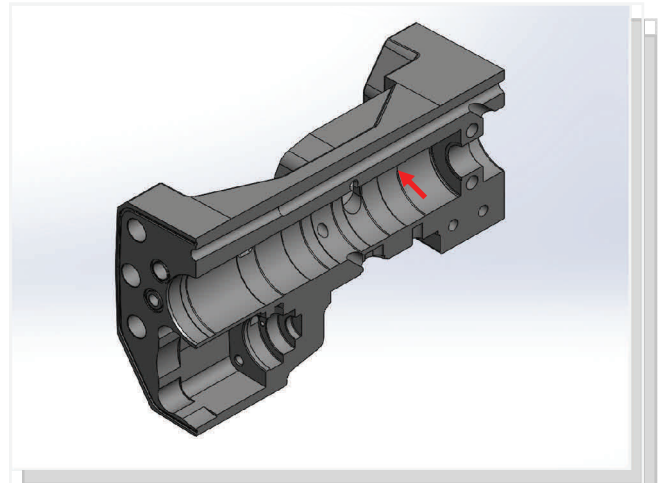
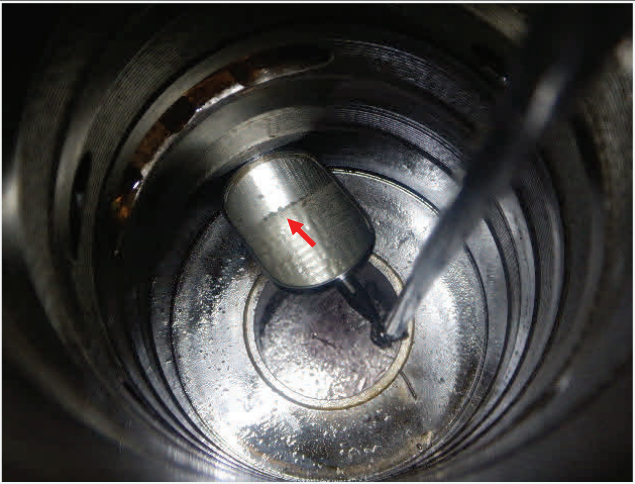
Ph (14) - Impact Body - Reference - Cavitation on top of rear land of cylinder bore.

Ph (15) - Impact Body - Reference - Cavitation on top of rear land of cylinder bore.

Impact Body - Gear Housing, HP Accumulator and HP&LP Adaptor mating faces skimmed this service - Overall length, bore dimensions, bore condition and fatigue life have been considered when analysing the overall condition of the Impact Body. The current condition is 45% of overall life.

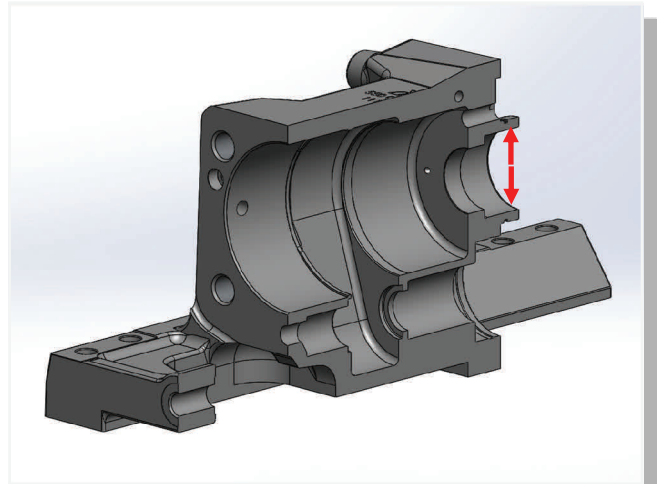
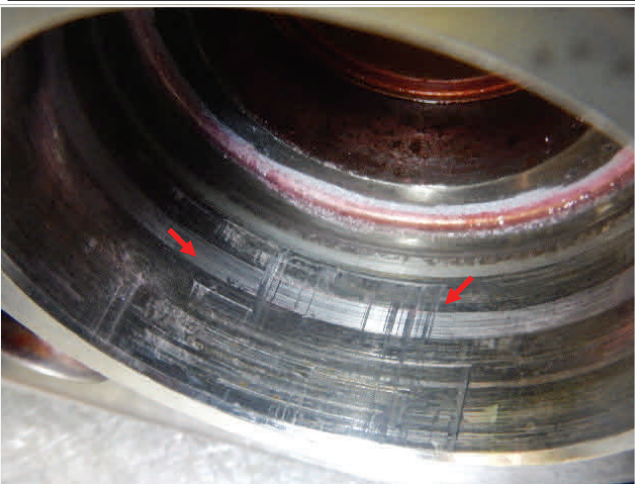
Ph (16) - Gear Housing - Machining - Front Piston Guide bore damaged, requires OS2 modification.

Ph (17) - Gear Housing - Machining - Front Piston Guide bore damaged, requires OS2 modification.
