# NIFTY COPPER PTY LTD

## STRIP AND QUOTE HLX5 ROCKDRILL -

### Sandvik Mining and Construction Pty Ltd Australia

Customer: NIFTY COPPER PTY LTD Date: 09/09/2019 Job number: 7395639

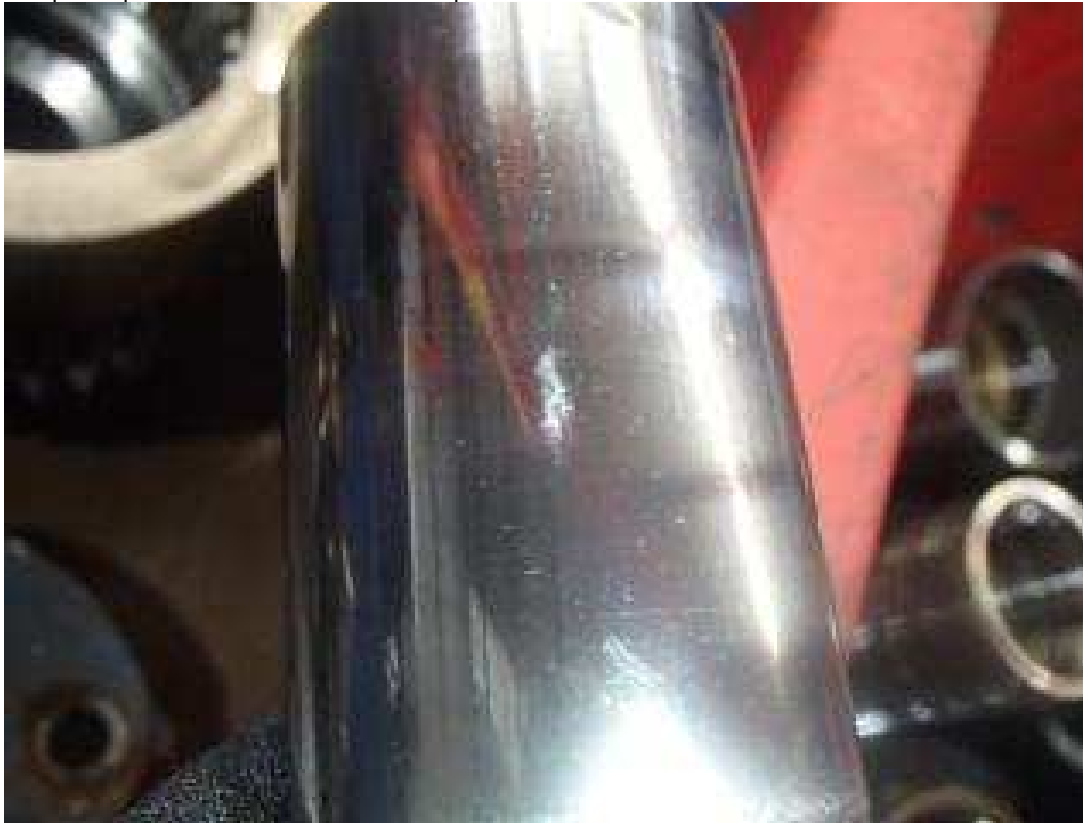
2 The piston percussion seal area is scored/pitted.

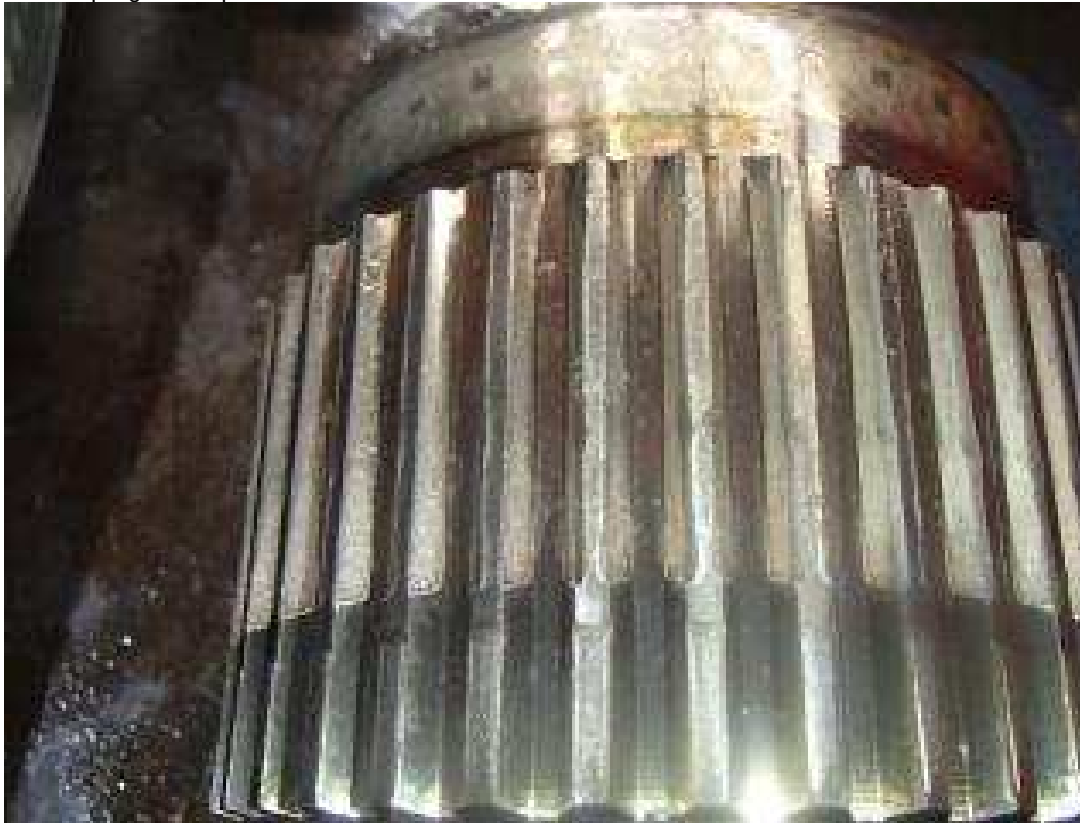
4 The coupling outer splines are worn thin.

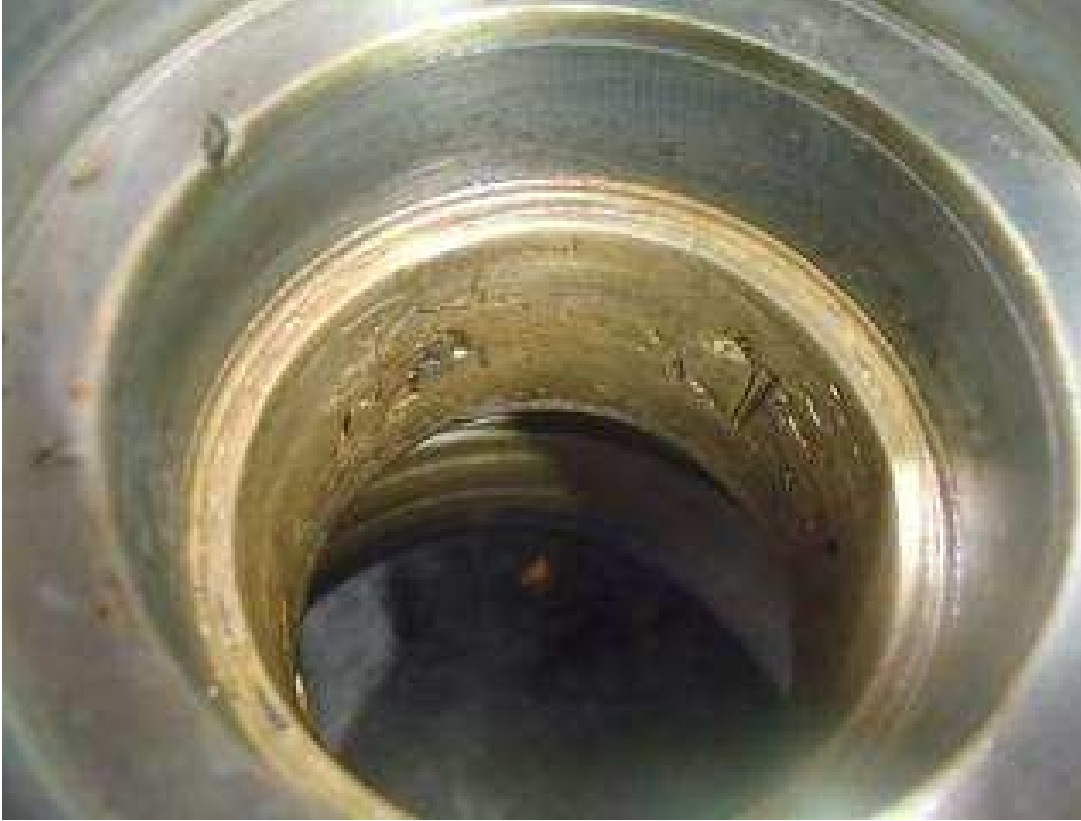
5 The gearcase rear bush is cavitated in the bore.

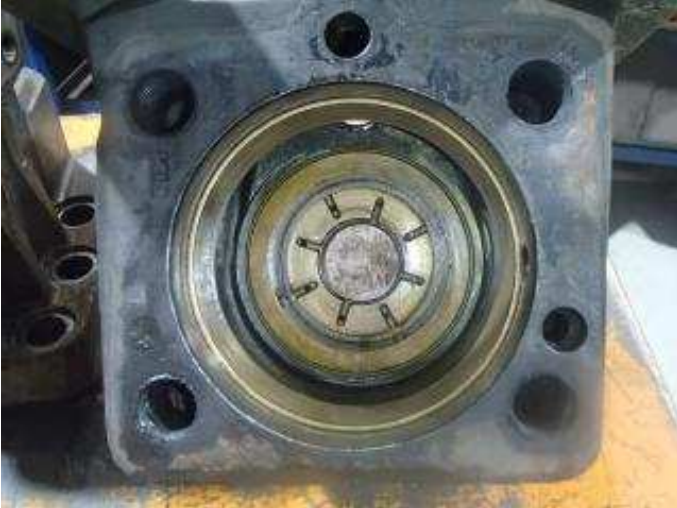
The gear case front face is unevenly worn, most likely caused by flushing housing bolts being loose at some stage. Requires skimming to square up the face and will remain within spec.

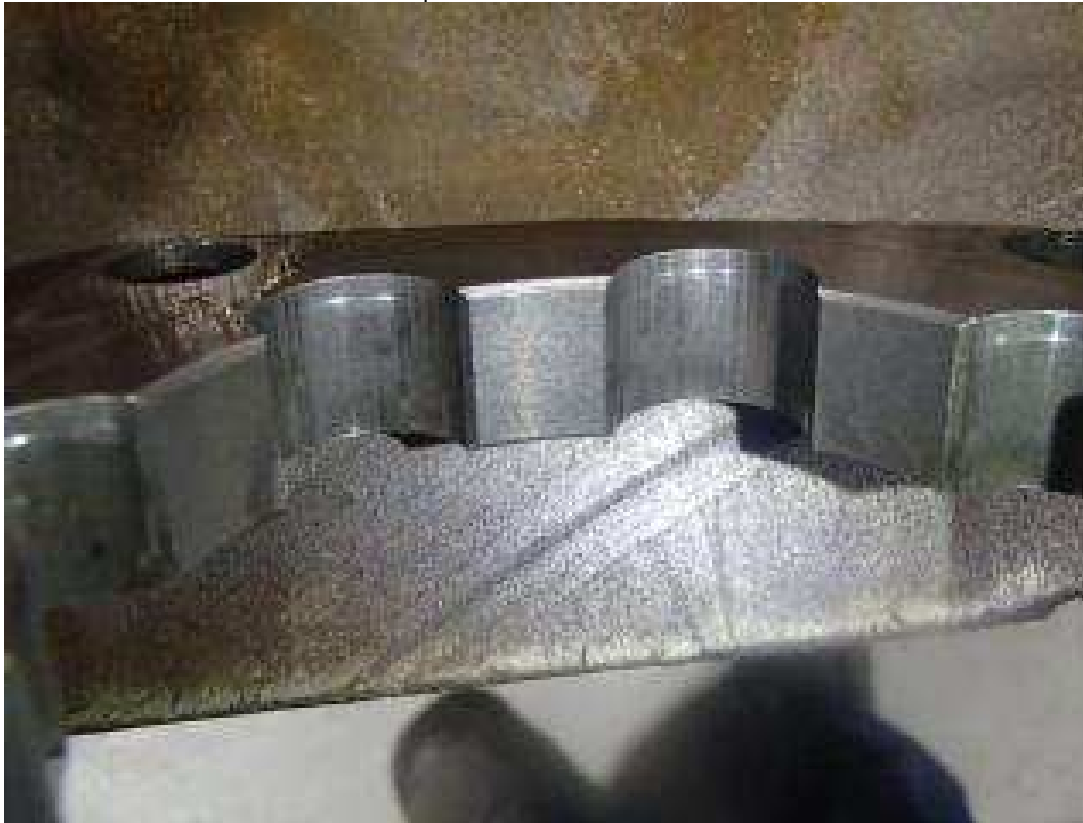
1 The motor internal is scored near the top end.

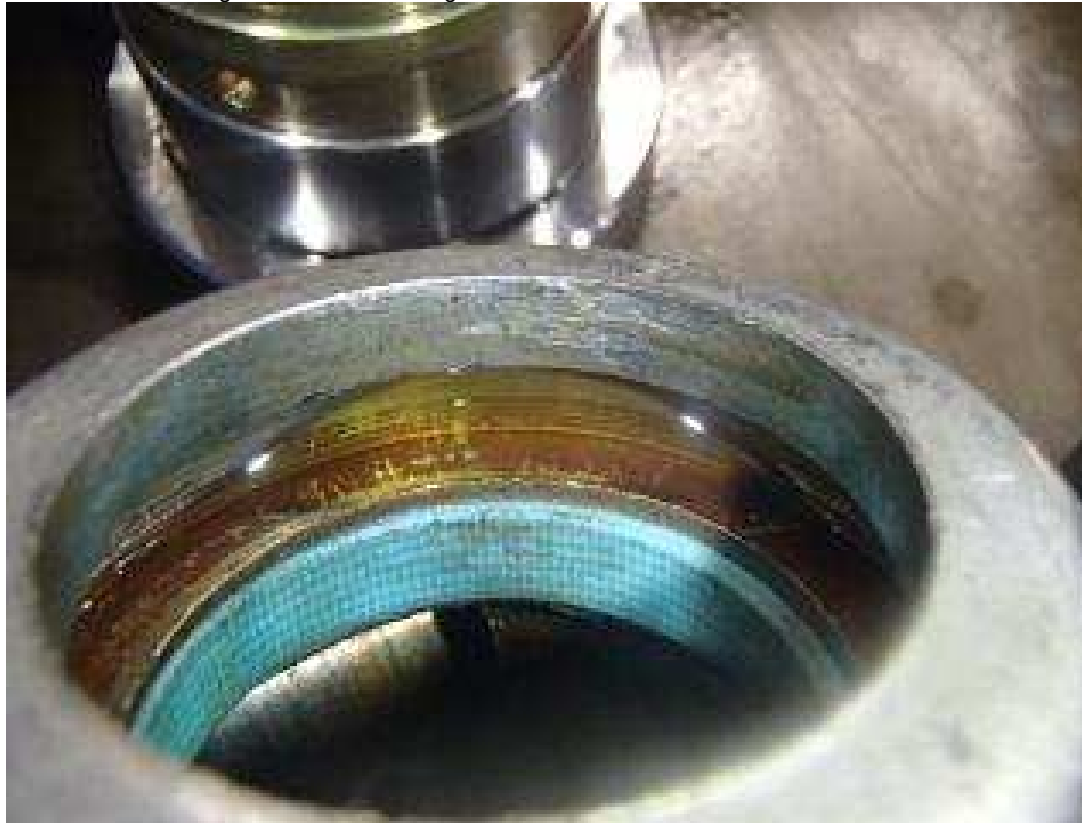
10 The seal carrier flange bore is worn from general wear

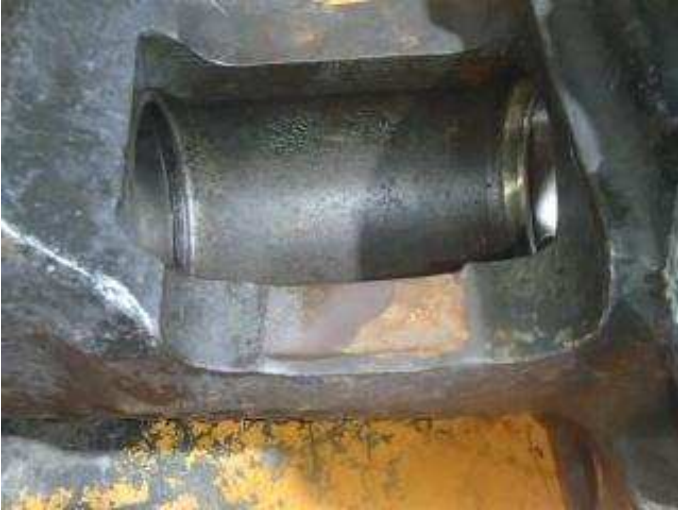
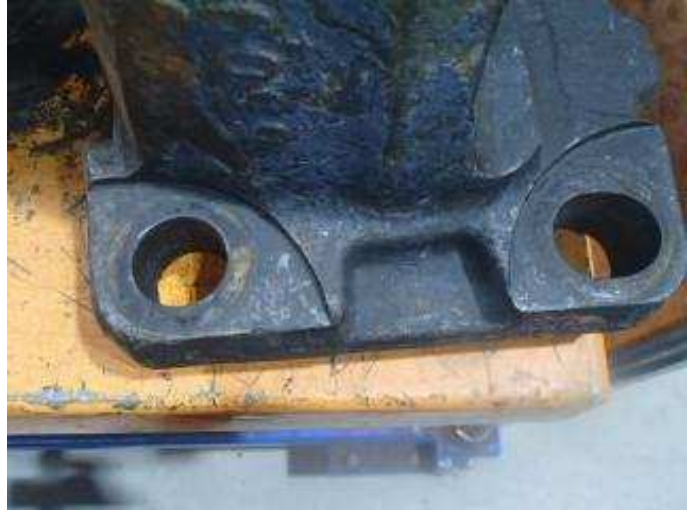
The flushing head requires repairs (build and machine) to the worn seal carrier land to extend its service life.  
 The mounting bolt lands are worn unevenly and need skimming to help prevent the bolts from coming loose.

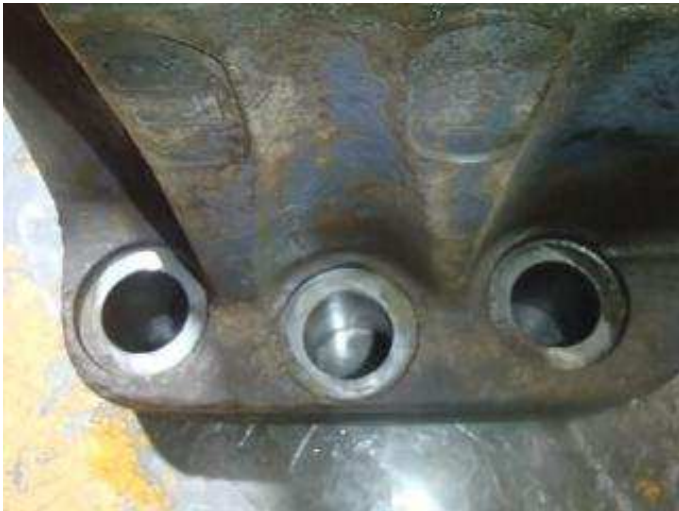
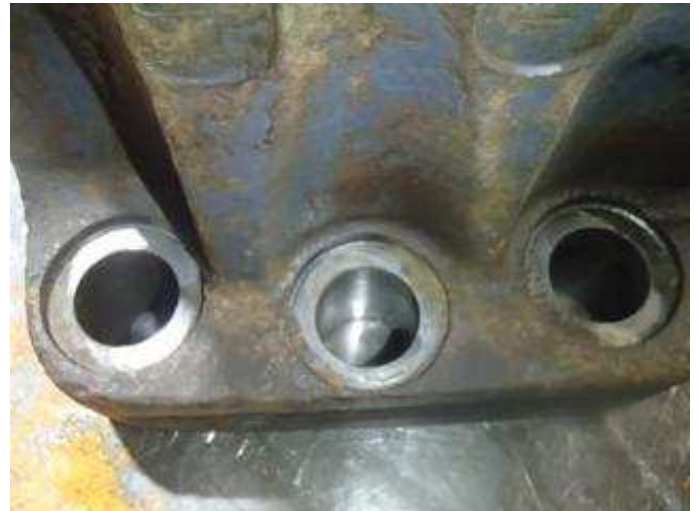
The percussion body need skimming to the corroded and unevenly worn tie nuts lands, to prevent the nuts from coming loose in the future. This corrosion is generally caused by the salty water in the underground environment that seeps under the nut face.
