NIFTY COPPER PTY LTD

STRIP AND QUOTE HLX5T ROCKDRILL-

Sandvik Mining and Rock Technology Pty Ltd Australia

Customer: NIFTY COPPER PTY LTD Date: 02/04/2019 Job number: 7389399

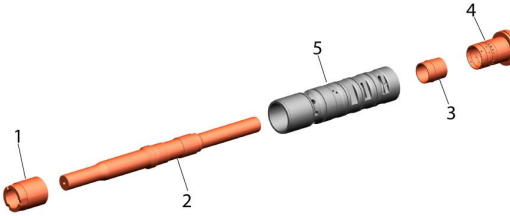
PERCUSSION KIT

The percussion components are in fair condition and will reuse again.

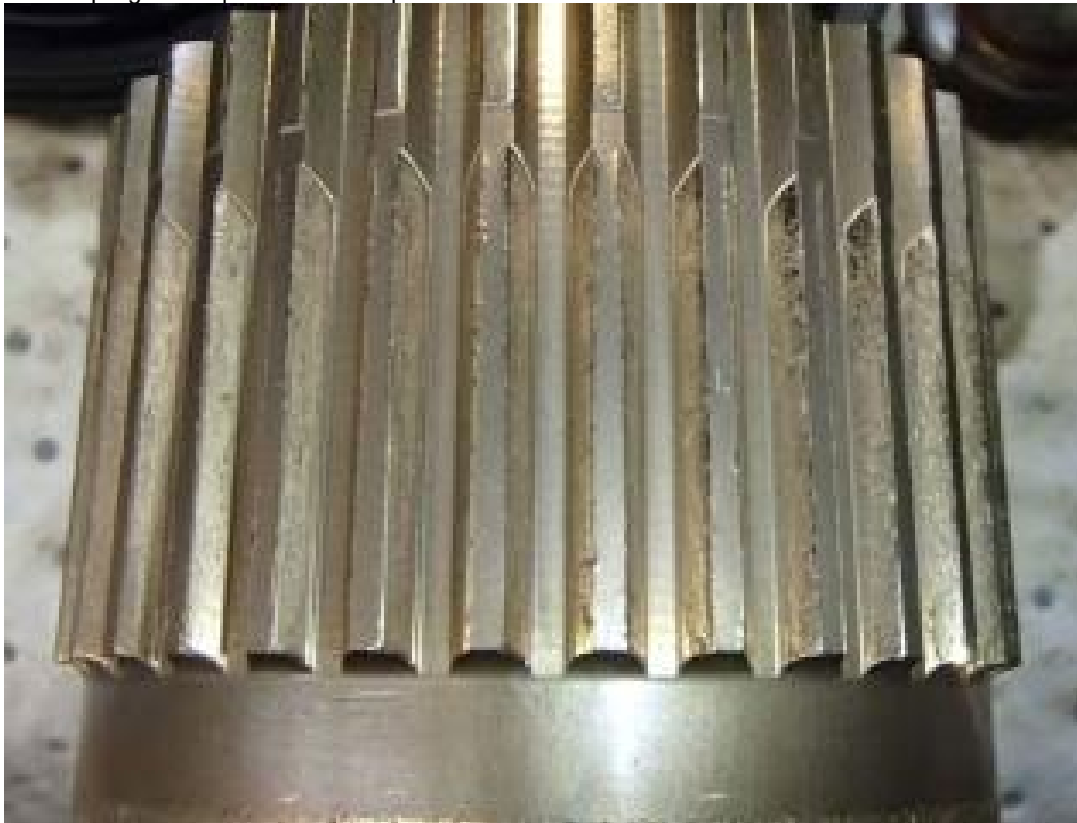
Ref.	Part Description	Qty	Failure code	Comment
1	COUPLING - INC ROTATION KIT	1	3	The coupling outer splines are worn past service limit.
5	HOUSING, BEARING	1	3	The bearing housing is worn where the thrust washer contact.

1 The coupling outer splines are worn past service limit.

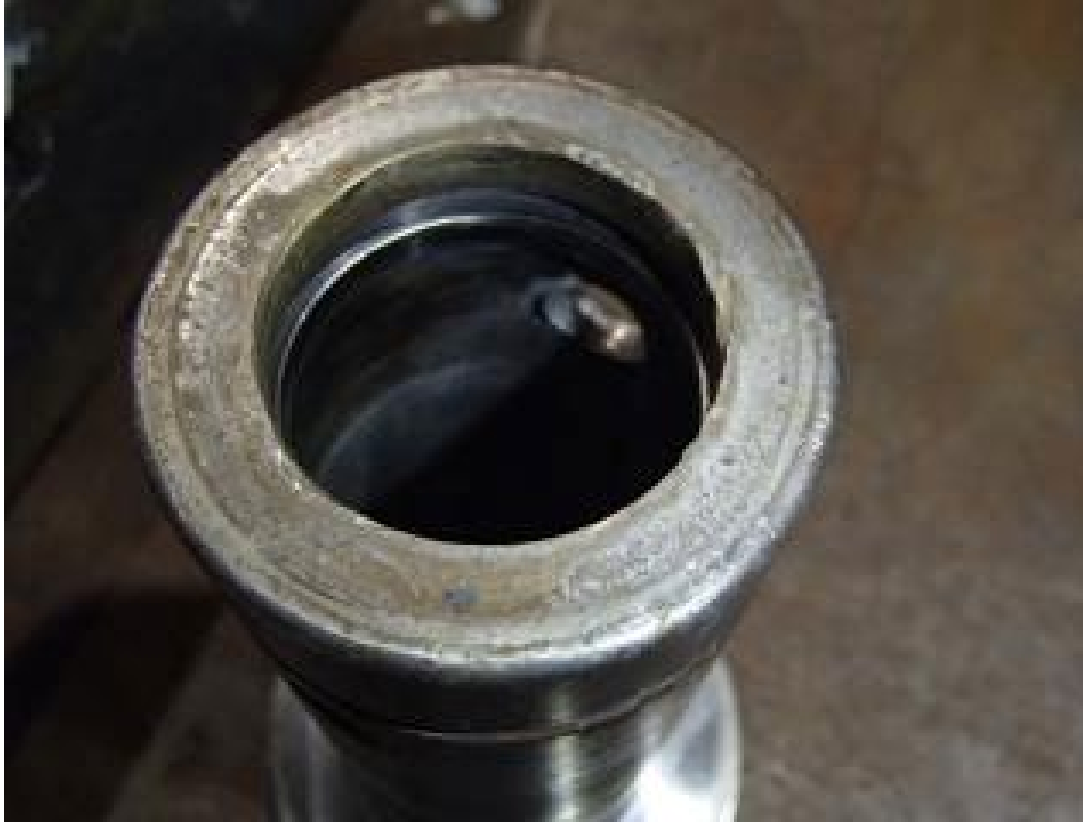
5 The bearing housing is worn where the thrust washer contact.

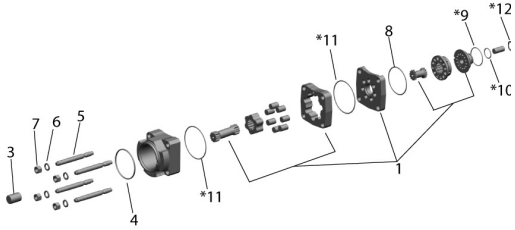
ROTATION MOTOR

80cc motor fitted. The motor internals are in fair condition and will reuse.

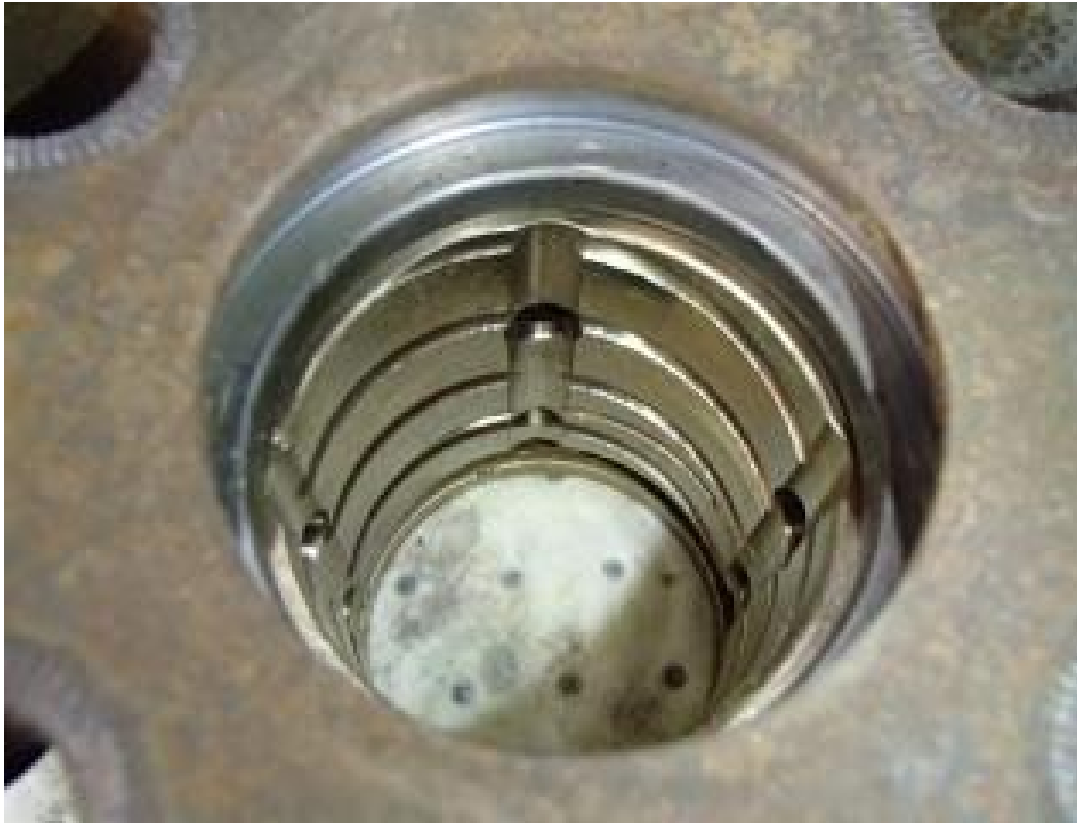
Ref.	Part Description	Qty	Failure code	Comment
*	FLUSHING HEAD REBUILD KIT - INCLUDES BG0800869	1	1	
3	BUSHING, BEARING	0	3	The front cover bush is worn.
4	BUSHING, SHANK	0	3	The rear shank bush striker face is pitted and starting to crack.

3 The front cover bush is worn.

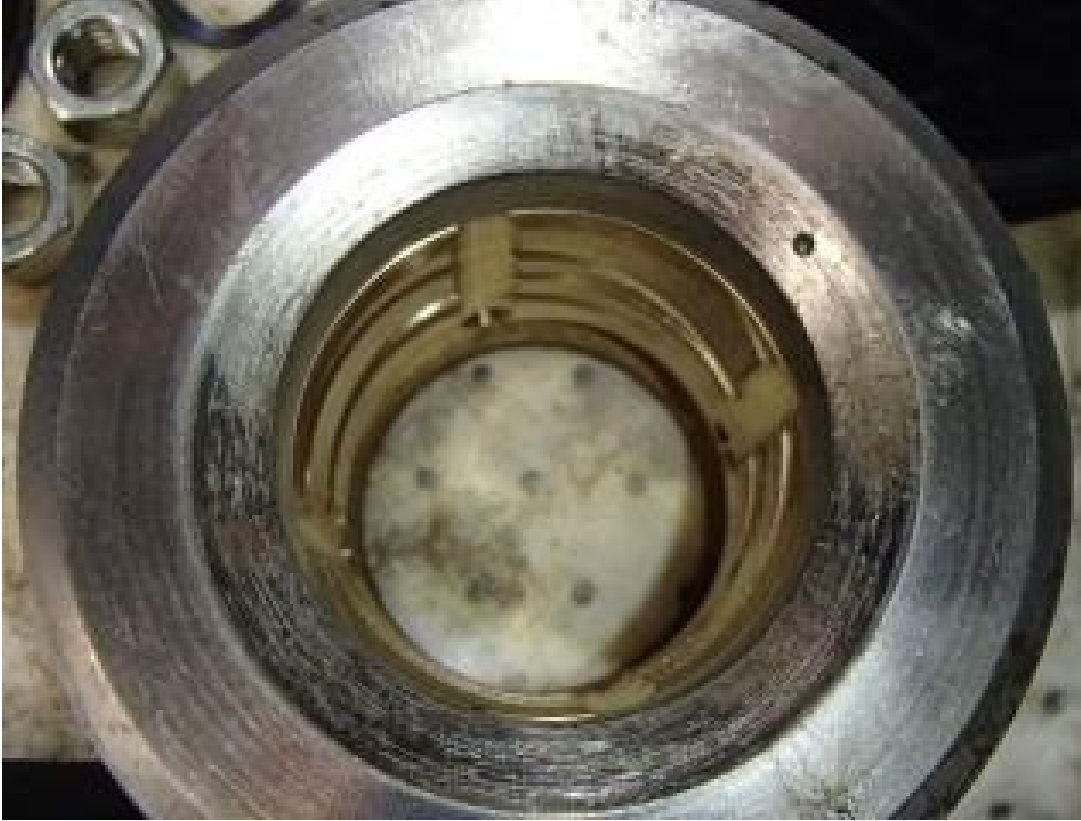
- 4 The rear shank bush striker face is pitted and starting to crack.

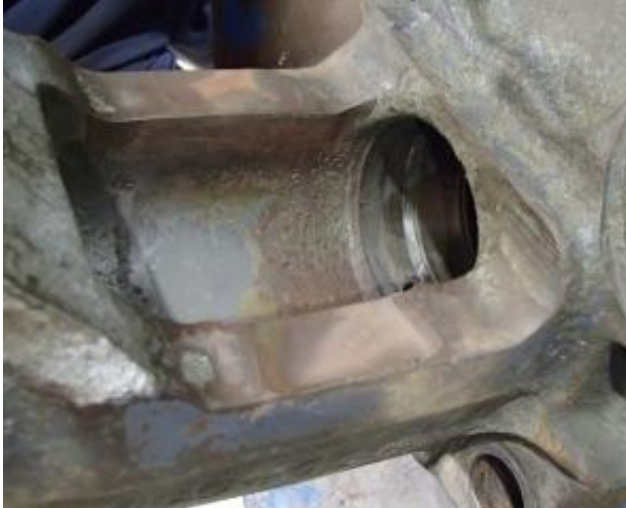
The flushing head requires repairs (build and machine) to the worn seal carrier land to extend its service life. Worn from general wear and tear that is relative to the achieved hours.

Flushing head.
