#### Sandvik HLX5D Rebuilt X048173

Service Report

#### Independence (Long Operations) HLX5D Serial No. X 048173 Service Report - Build 6

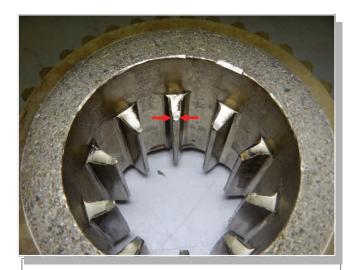
**Ph (1) - GH - Driver -** Replaced - Internal spline teeth worn below specifications.

**Ph (3) - FH - Seal Housing - Replaced - Seal groove wall damaged, will not hold wear strip.**

**Ph (5) - Gear Housing - Reference - Rope post bracket** cracked at weld, requires grind and weld to repair.

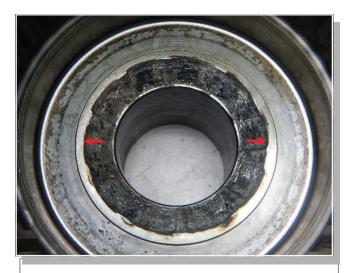
**Ph (2) - GH - Rotation Chuck -** Replaced - Shank contact face damaged and will not clean up within specifications.

**Ph (4) - FH - Seal Housing -** Replaced - Seal groove wall damaged, will not hold wear strip.

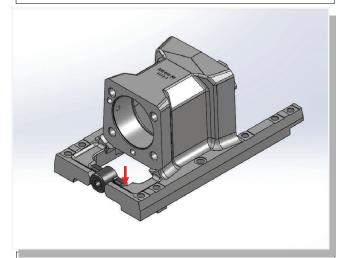
**Ph (6) - Gear Housing - Reference - Rope post bracket** cracked at weld, requires grind and weld to repair.

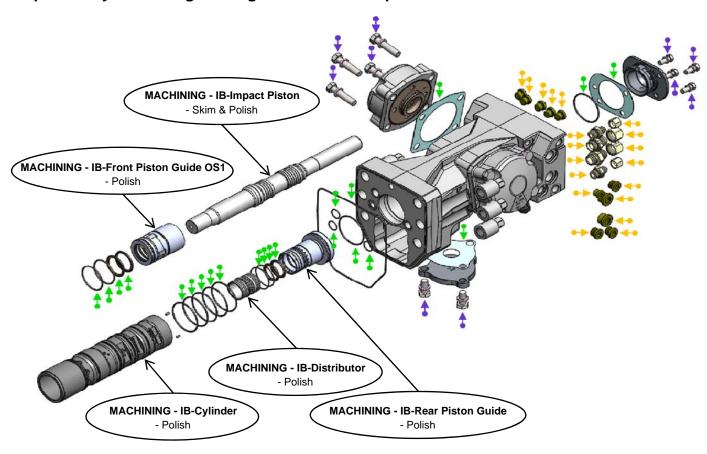
### **Impact Body Machining and Significant Items Replaced**

**Impact Body** - Rear Cover, HP Accumulator & Tie Rod mating faces skimmed and Main bore honed this service - Overall length, bore dimensions, bore condition and fatigue life have been considered when analysing the overall condition of the Impact Body. The current condition is 40% of overall life.

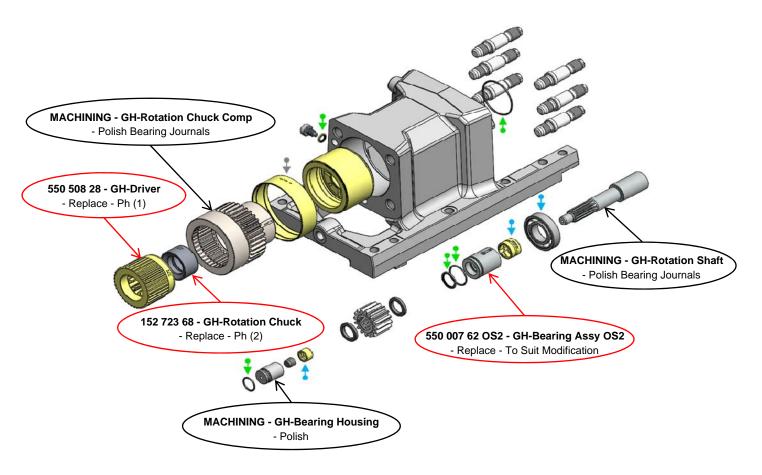
#### **Gear Housing Machining and Significant Items Replaced**

**Gear Housing** - Flushing Head mating faces skimmed, Cradle pull bolt bracket welded & machined and Bearing Assembly OS2 Modification conducted this service - Overall length, bore dimensions, bore condition and fatigue life have been considered when analysing the overall condition of the Gear Housing. The current condition is 50% of overall life.
