#### 2010 Atlas Copco COP1838 Incomplete with Parts AVO10D605E

Service Report

Drill Assessed: COP 1838 MUX - AVO 10D 605E

#### Independence (Long) COP 1838 MUX SN AVO 10D 605E Service Report - Build 2

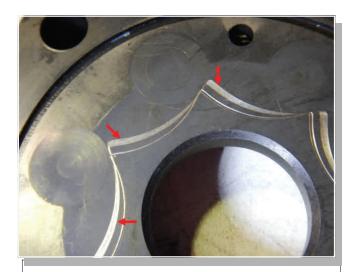
**Ph (1) - OMS 160 Motor** - Replaced - Scored on gerola mating face .

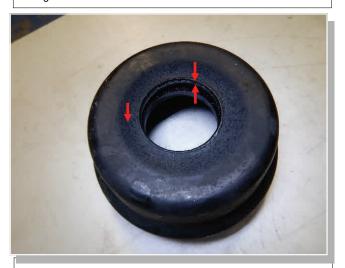
**Ph (3) - MUX-FH-Seal Retainer -** Replaced - Front face worn close to seal groove.

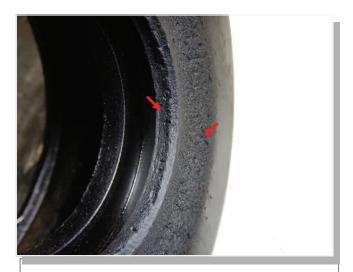
**Ph (2) - MUX-FH-Seal Retainer -** Replaced - Front face worn close to seal groove.

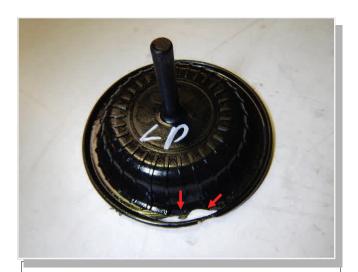
Ph (7) - LP Accumulator - Reference - Damaged diaphragm.

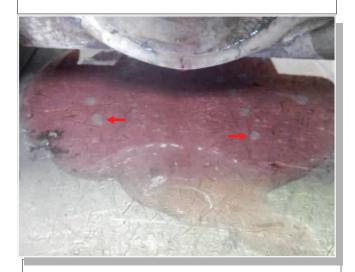
Ph (11) - Damping Housing - Reference - Water Contamination

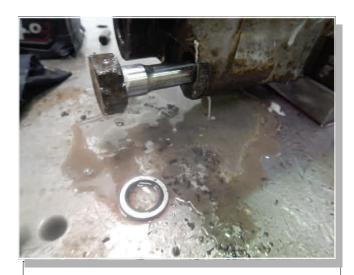
$\label{eq:Phi} \textbf{Ph (8) - Gear Housing} \ \text{-} \ \text{Reference - Water Contamination}$

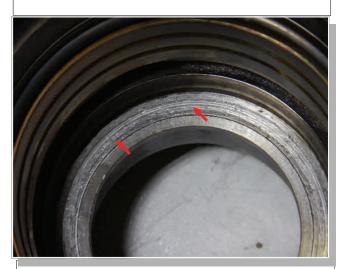
**Ph (10) - Damping Housing -** Reference - Evidence of over feeding. Damping piston to shoulder contact

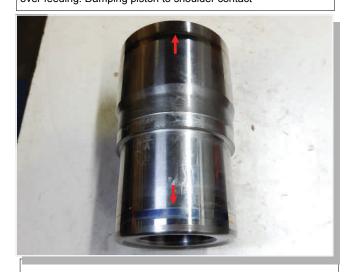
**Ph (12) - Damping Piston** - Reference - Overheating of the damping seals

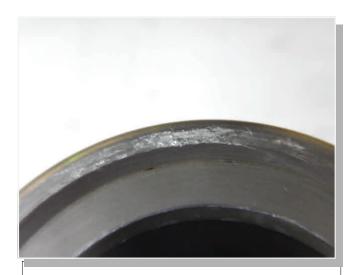
**Ph (13) - Damping Piston -** Reference - Evidence of over feeding. Damping piston to shoulder contact

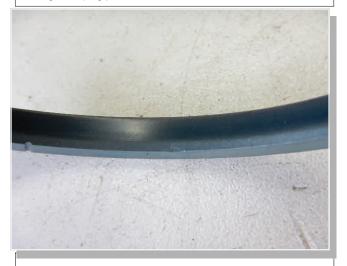
Ph (15) - Damping Piston Seals - Reference - Overheated

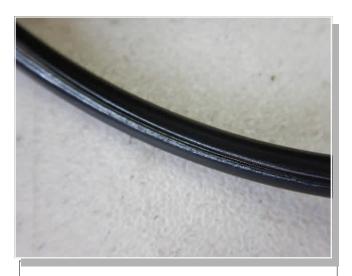
**Ph (14) - Damping Seal Energiser - Reference - Over heated / Compression Set**

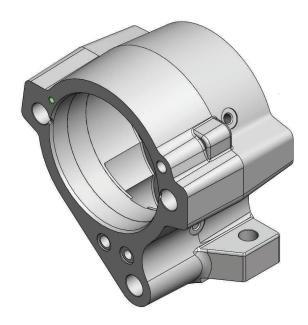
MACHINING - Cover Plate - Repair Crack

**Cover Plate -** No work required this service -Overall length, bore dimensions, bore condition and fatigue life have been considered when analysing the overall condition of the Cover Plate. The current condition is 100% of overall life.
