# NIFTY COPPER PTY LTD

## STRIP AND QUOTE HLX5T ROCKDRILL

### Sandvik Mining and Construction Pty Ltd Australia

Customer: NIFTY COPPER PTY LTD Date: 09/07/2019 Job number: 7393445

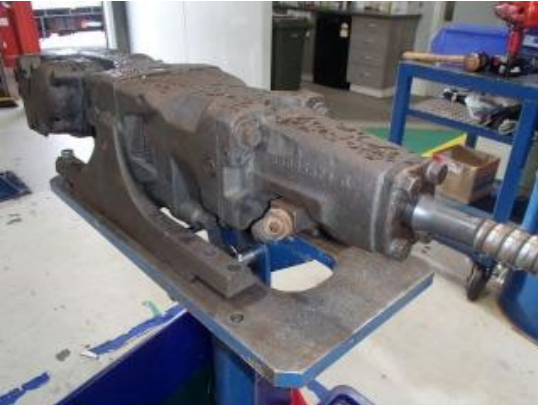
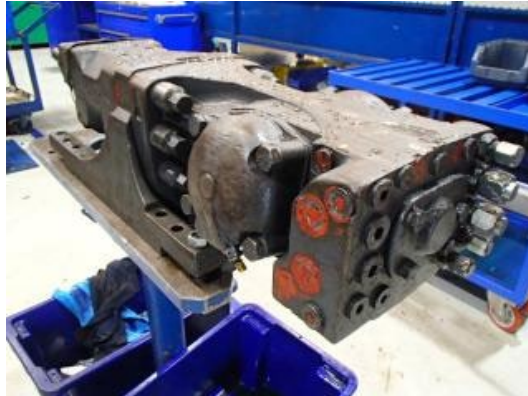
Arrived in a steel box. Complete with flushing head, seal carrier and shank.

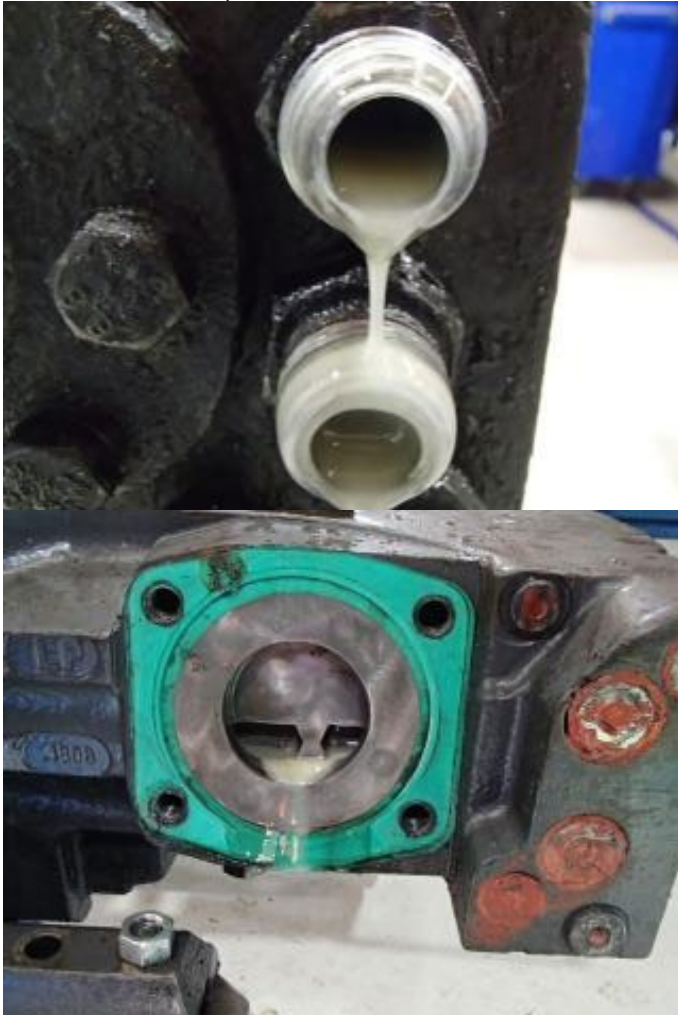
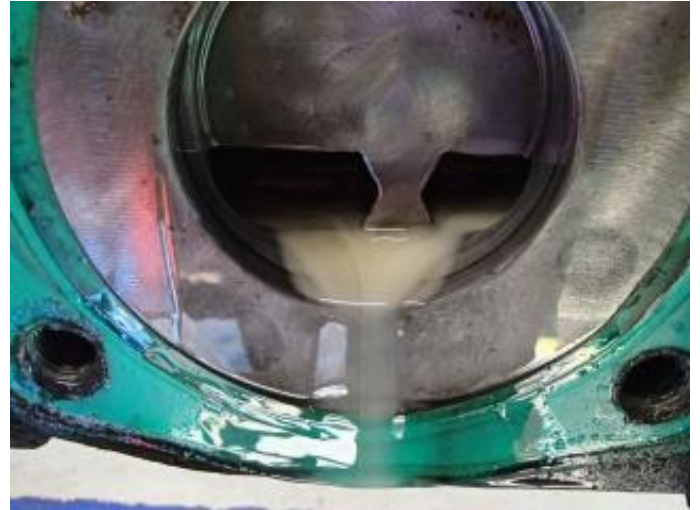
Upon dismantling the percussion circuit was found water contaminated which has most likely occurred only recently/shortly before removal as there is minimal evidence of subsequent damage or increased wear rates.

Water contaminated percussion circuit.

Investigate source of water contamination, check oil coolers etc.

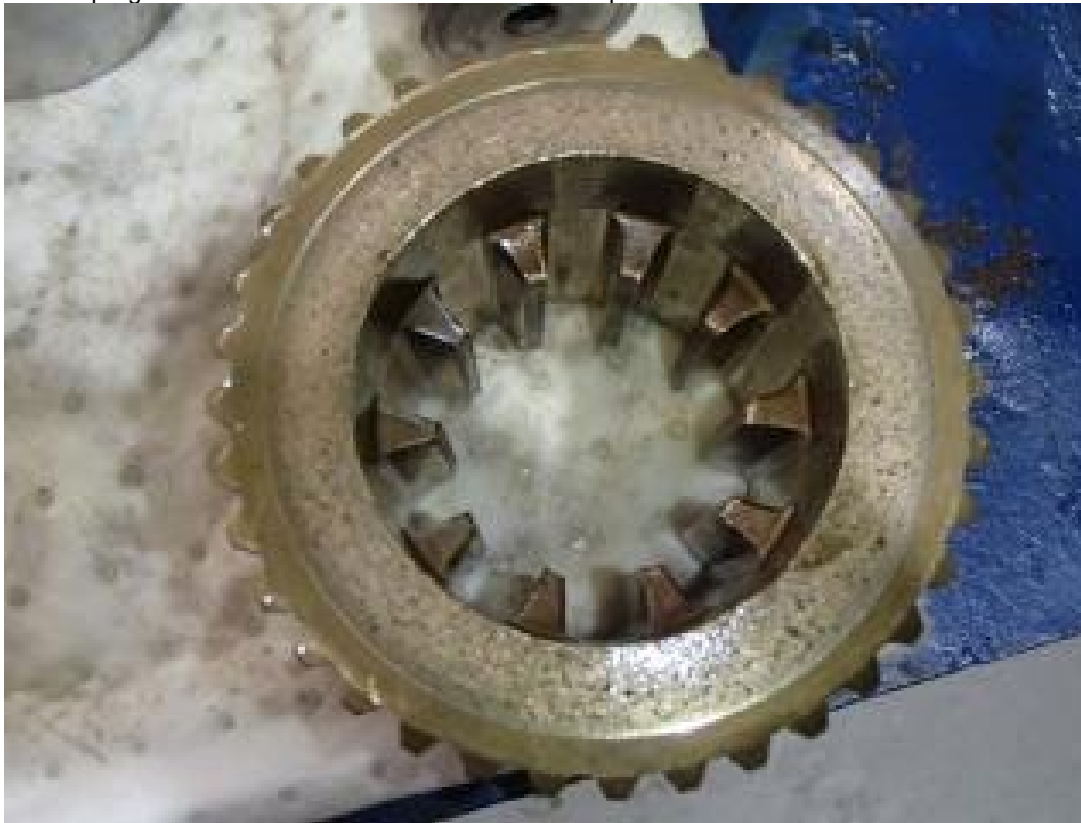
1 The coupling is worn near to service limit at the internal splines.

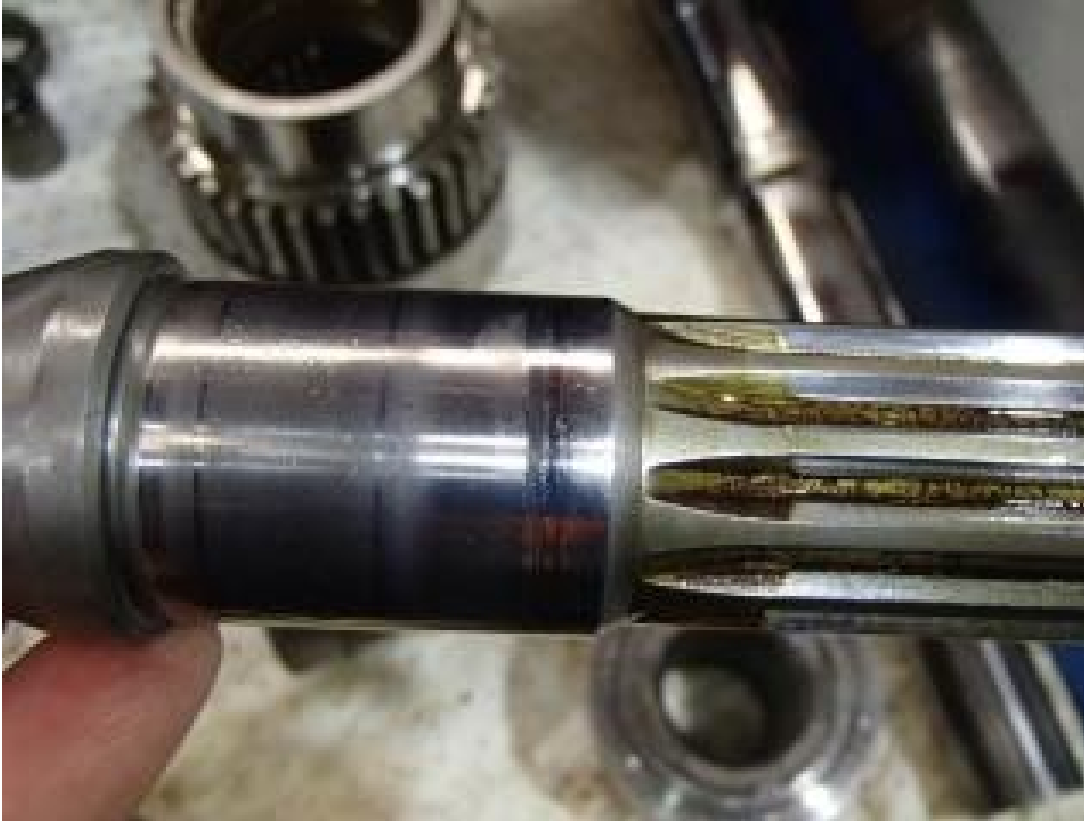
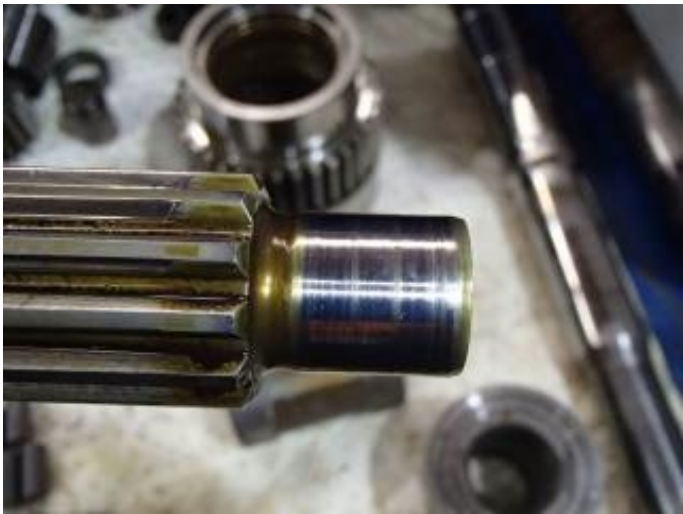
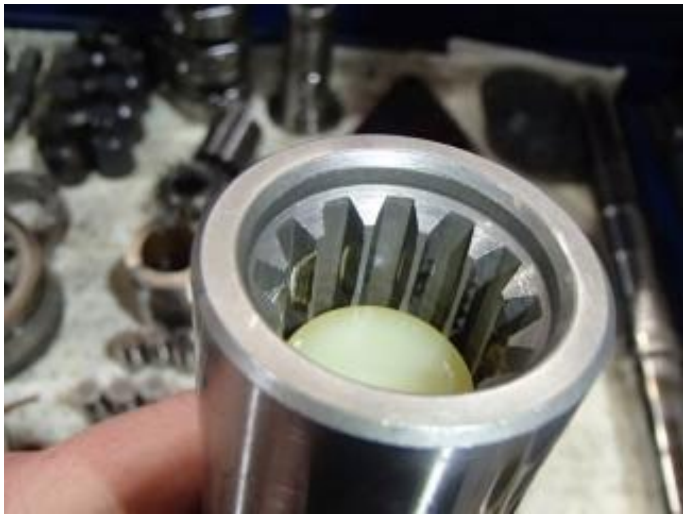
4 The rotation shaft has worn at the seal journal, spigot bearing journal and internal splines.

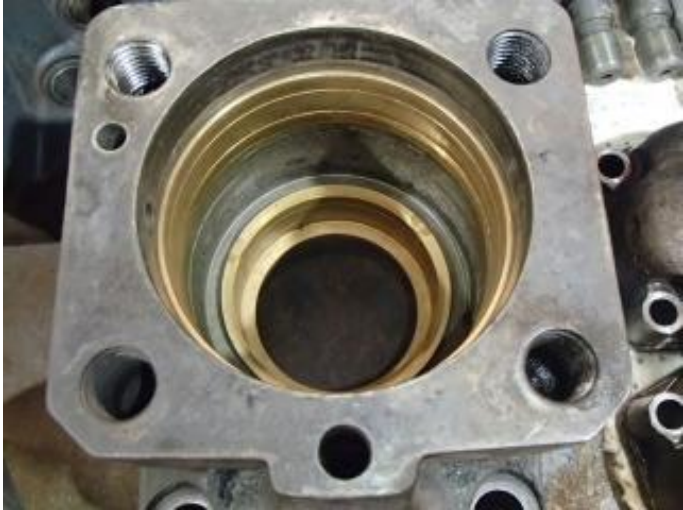
The gearcase requires a light skim to the worn front face.

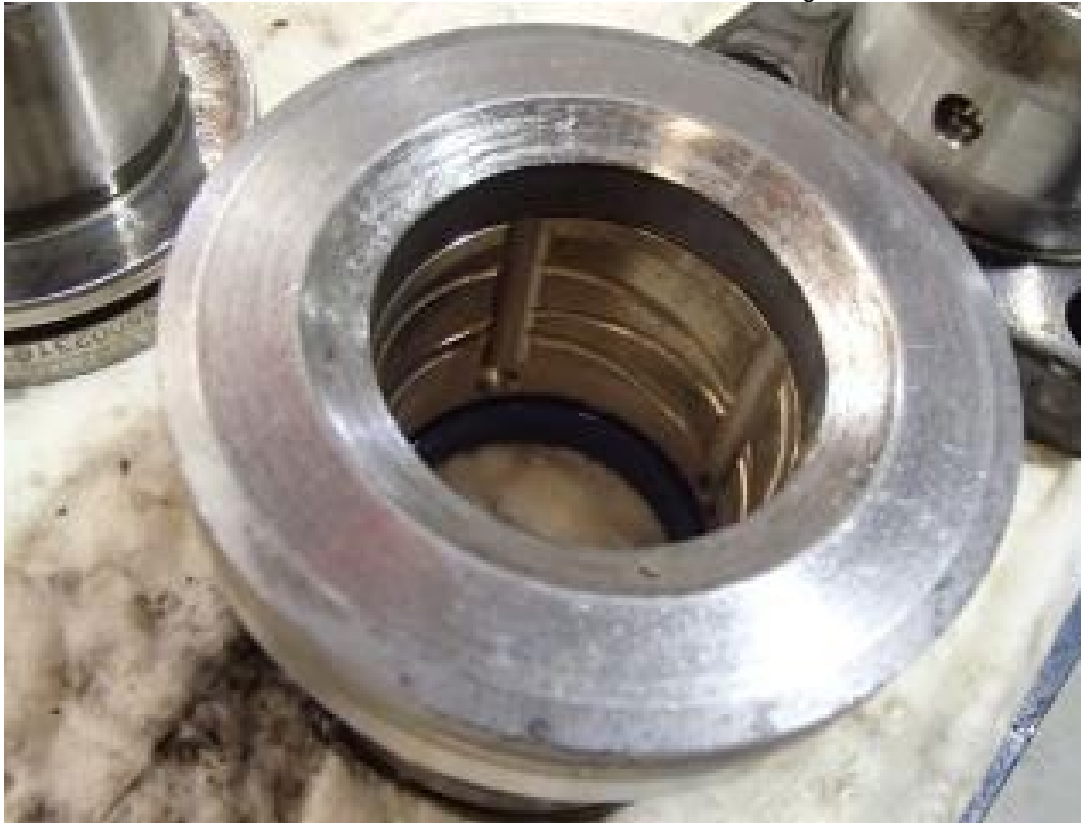
\* The shank bush is worn to limit at the striker face but included in the flushing head rebuild kit.

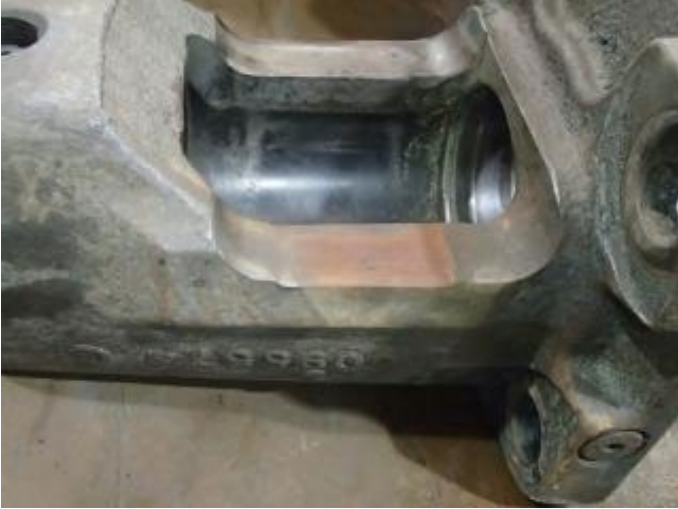
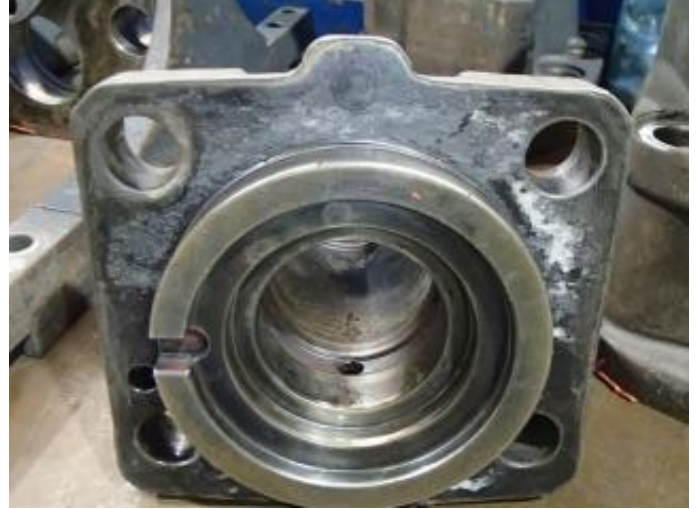
The flushing head body requires repair to the seal carrier seat and a light skim to the rear face.
