# 2007 Hino GT1J Tray Truck with Compressor

### **B-ST16 OPERATION AND CONDITION REPORT FEBRUARY 2016**

#### 02/07 Hino Ranger GT1J. JHDGT1JKPXXX10648

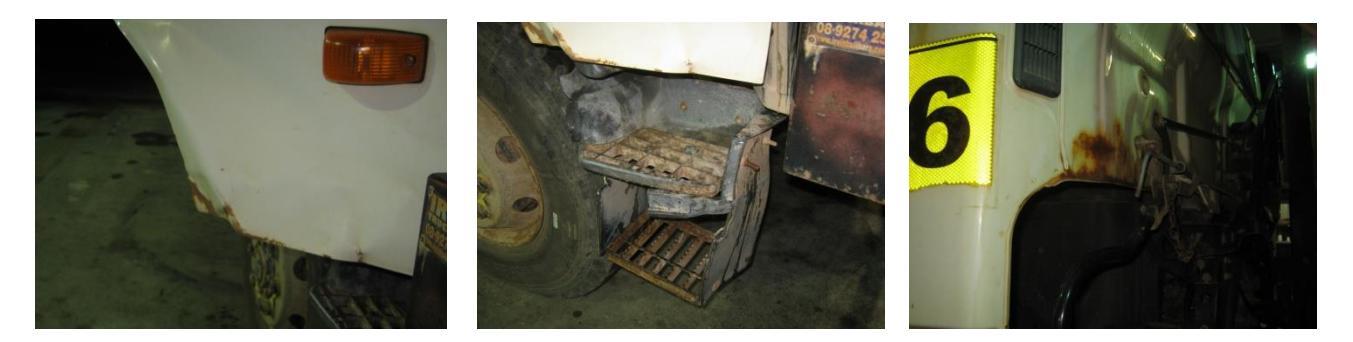
General body condition is poor, damage to steps and driver's door. Rust in several locations.

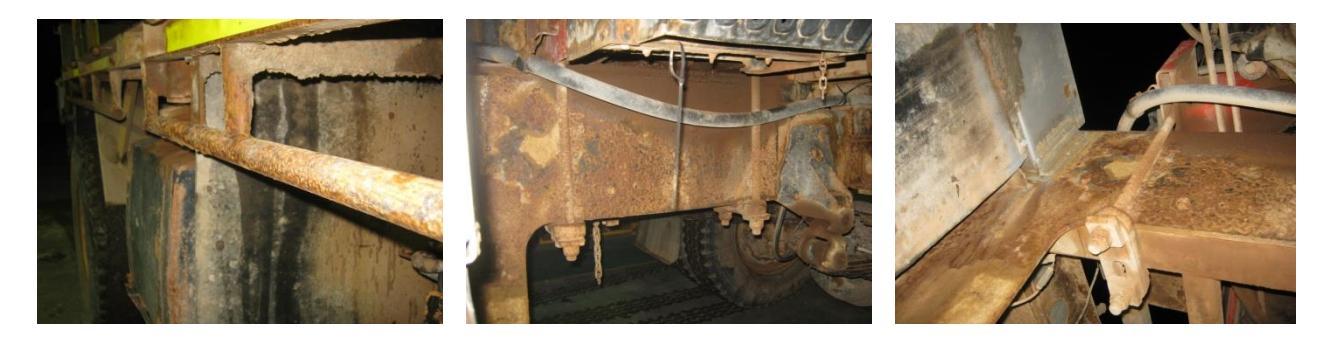
Chassis has excessive rust at rear suspension mounting locations, along main chassis rails, tie down rails and headboard.

Wheel rims will require inspection as rust present, may require repair or replace.

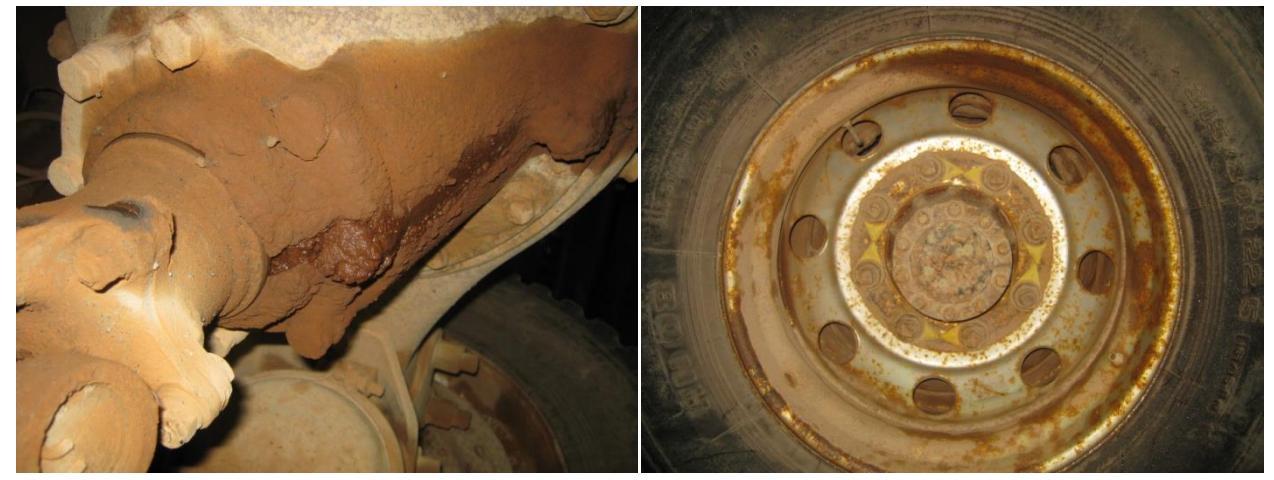
Driveline components have achieved 9305 hrs and showing signs of wear, replacement components currently required for continued reliability. Driveline components have excessive movement and leaking seals. Swivel hubs require an overhaul as currently leaking and movement present.

Gearbox, clutch and flywheel are due replacement, as is the transfer case and all driveshaft's. All air tanks, wheels cylinders and brakes will require service or replacement for continued operation HIAB requires repairs to leaking slew cylinder. Offsite repairer to carry out this and full service. Majority of components are readily available and scheduled in budget forecast.
