Sandvik HLX5D Rebuilt X048240

National Service Department
Service Report

Drill Assessed: HLX5D - X 048240

ROCKDRILL SERVICE REPORT

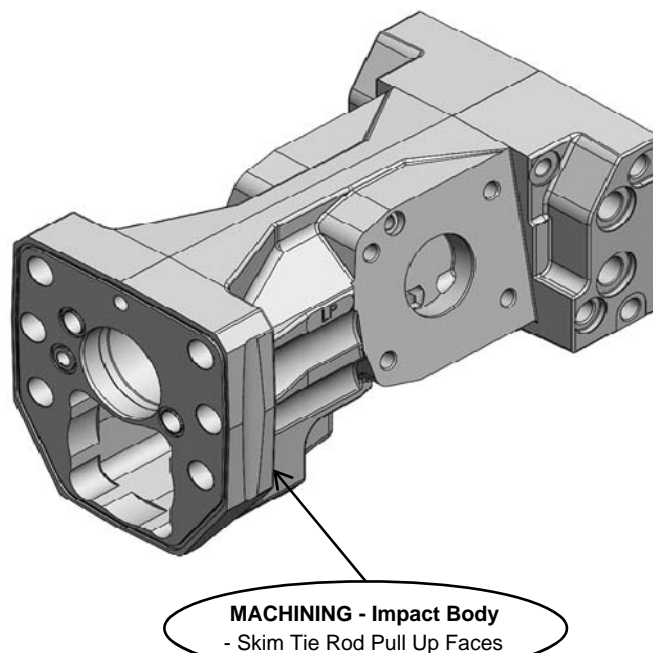
Impact Body Machining Required

Impact Body - Tie Rod mating faces skimmed this service - Overall length, bore dimensions, bore condition and fatigue life have been considered when analysing the overall condition of the Impact Body. The current condition is 45% of overall life.

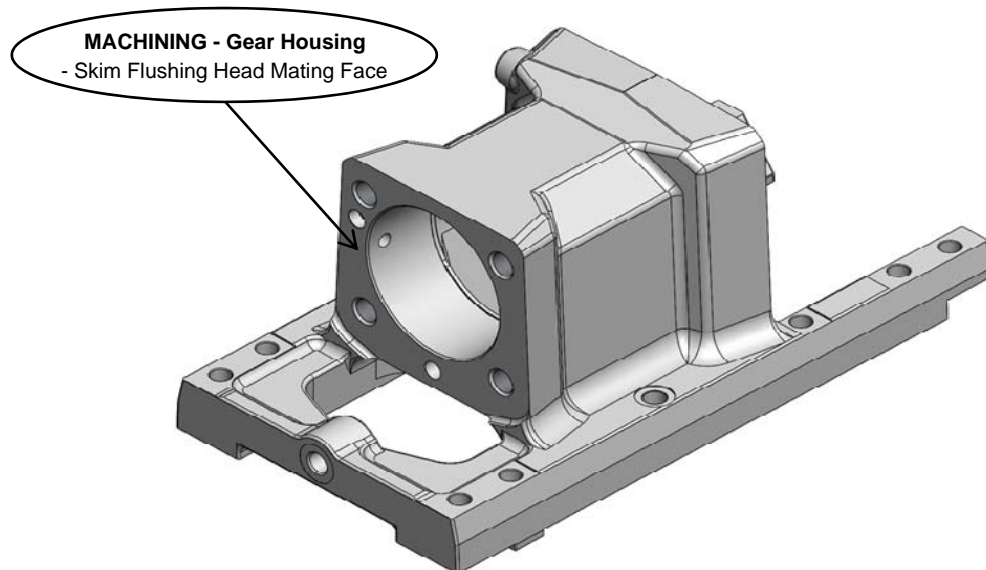
Gear Housing Machining Required

Gear Housing - Flushing Head mating face skimmed this service - Overall length, bore dimensions, bore condition and fatigue life have been considered when analysing the overall condition of the Gear Housing. The current condition is 30% of overall life.

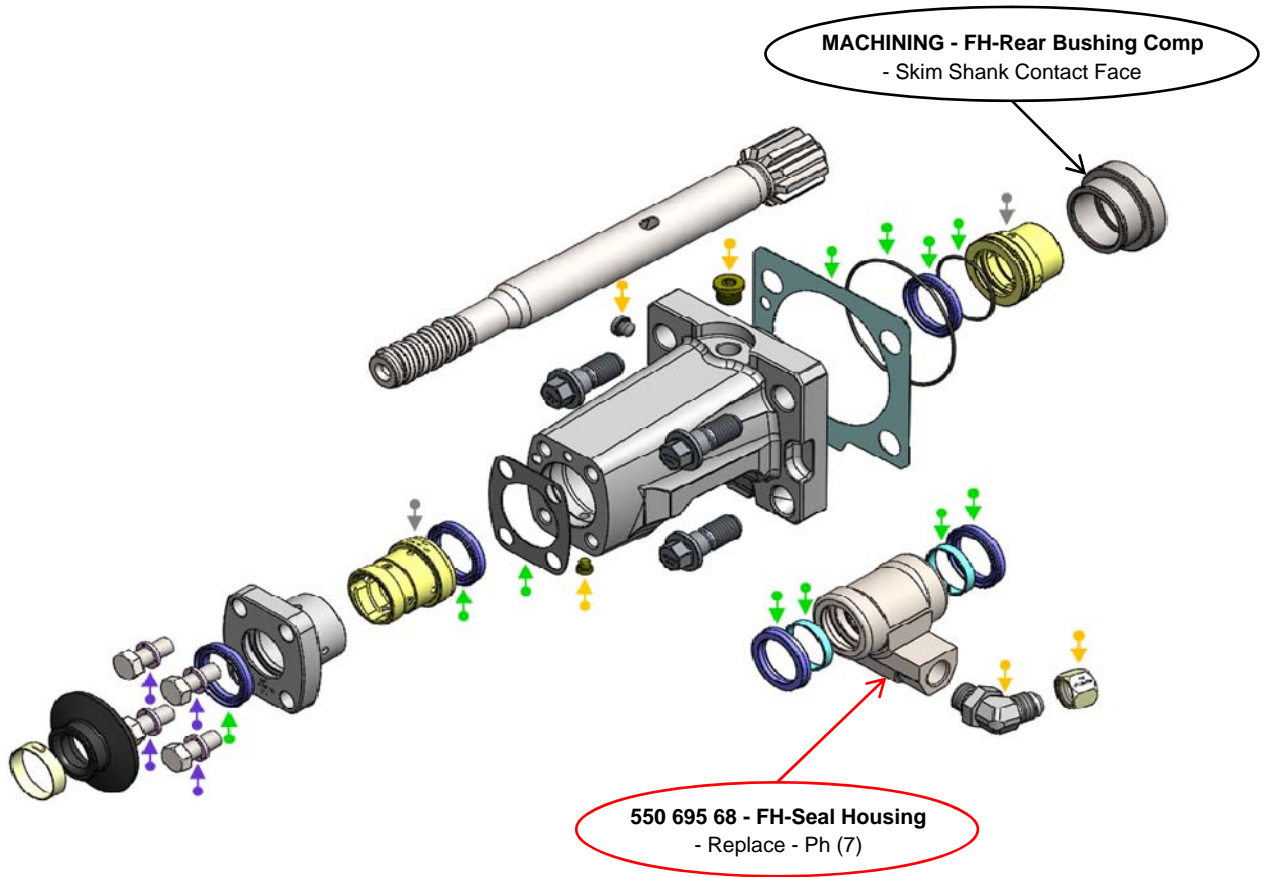
Flushing Head Machining and Significant Items Replaced

Ph (7) - FH Seal Housing - Replaced - Damaged.

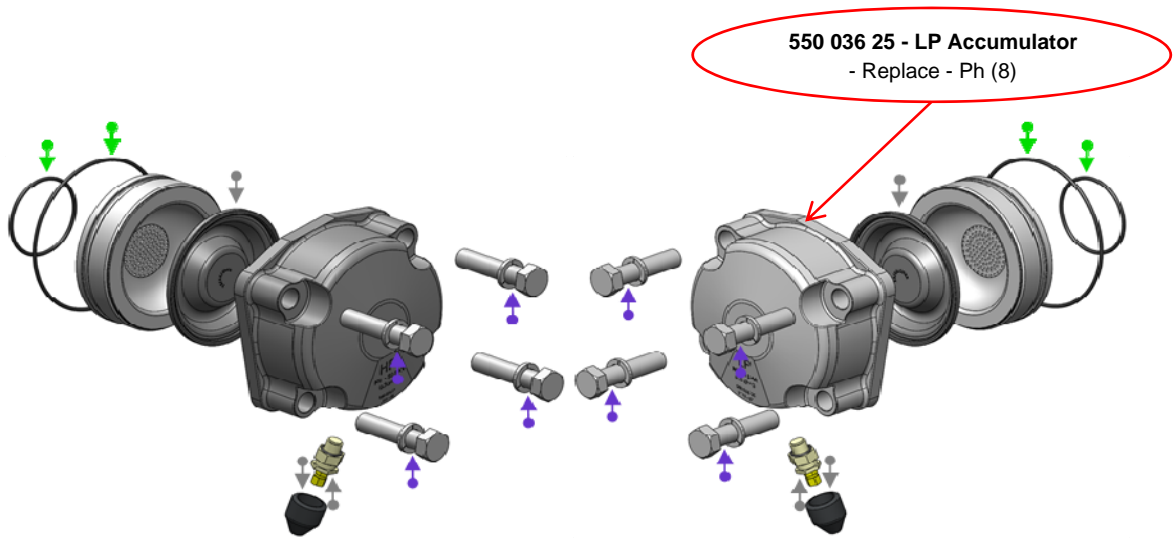
Accumulator Machining and Significant Items Replaced

Ph (8) - LP Accumulator - Replaced - Not With Machine - 2x HP supplied - Second Hand in Spec Unit Supplied.
