# NIFTY COPPER PTY LTD

## STRIP AND QUOTE HLX5T ROCKDRILL

Customer: NIFTY COPPER PTY LTD      Date: 09/10/2019      Job number: 7396941

Your STRIP AND QUOTE HLX5T ROCKDRILL: **HLX5T KIT**, S/No **R048431** arrived in our Kalgoorlie rebuild centre on the 3/10/2019 with 1033 hours.

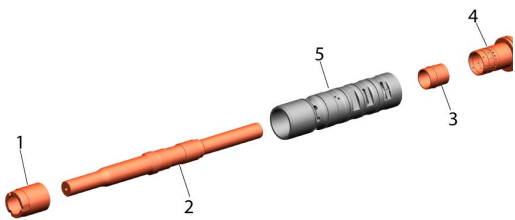
Ref.	Part Description	Qty	Cond. code	Comment
1	BEARING - INC PERCUSSION KIT	1	3	The front bush is starting to crack.

1 The front bush is starting to crack.

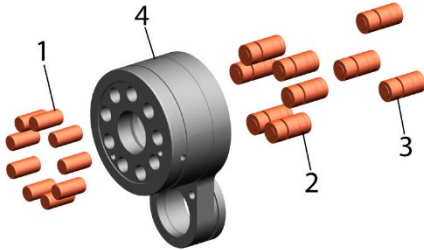
The spacer stabilizer piston bores are worn. Will replace the stabilizer pistons with the alternate type which has the seals locate higher in the bore.

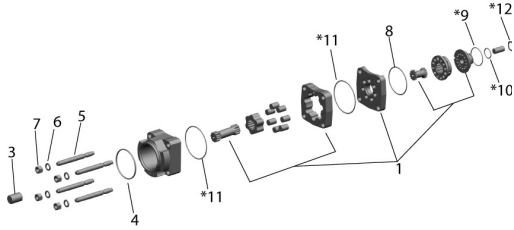
80cc motor fitted. The motor internals are in fair condition and will reuse again.

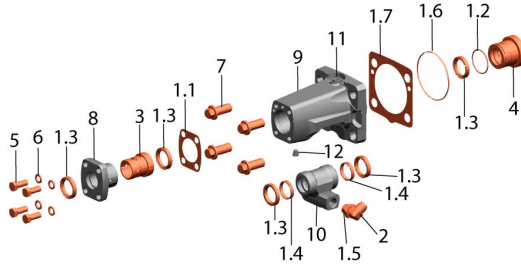
The flushing head requires repairs (build and machine) to the worn seal carrier land to extend its service life

Machining Required: Spacer Body and Flushing head.

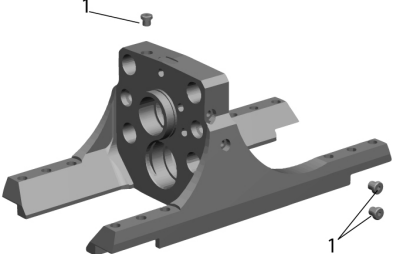
The spacer body mounts are worn and require machining.
