# NIFTY COPPER PTY LTD

## STRIP AND QUOTE HLX5 ROCKDRILL

Customer: NIFTY COPPER PTY LTD Date: 16/07/2019 Job number: 7393736

Your STRIP AND QUOTE HLX5 ROCKDRILL: **HLX5 KIT**, S/No **T048214** arrived in our rebuild centre on the 5/07/2019 with 1019 hours.

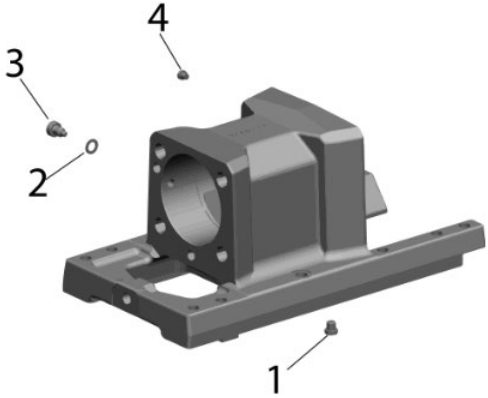
**GEARBOX**

The gear-box requires repairs to the cracked and worn rope mount, skim the front face and resleeve the rear bush bore.

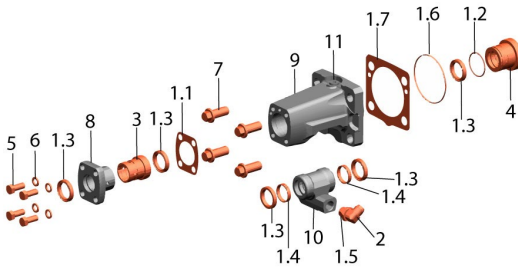
# FLUSHING KIT

The worn bushes are included in the rebuild kit and the flushing head body requires repair to the worn seal carrier seat.
