Sandvik HLX5D Incomplete N048123

National Service Department
Service Report

Drill Assessed: HLX5D - N048123

Independence (Long Shaft) HLX5D Serial No. N048123 Service Report - Build 1

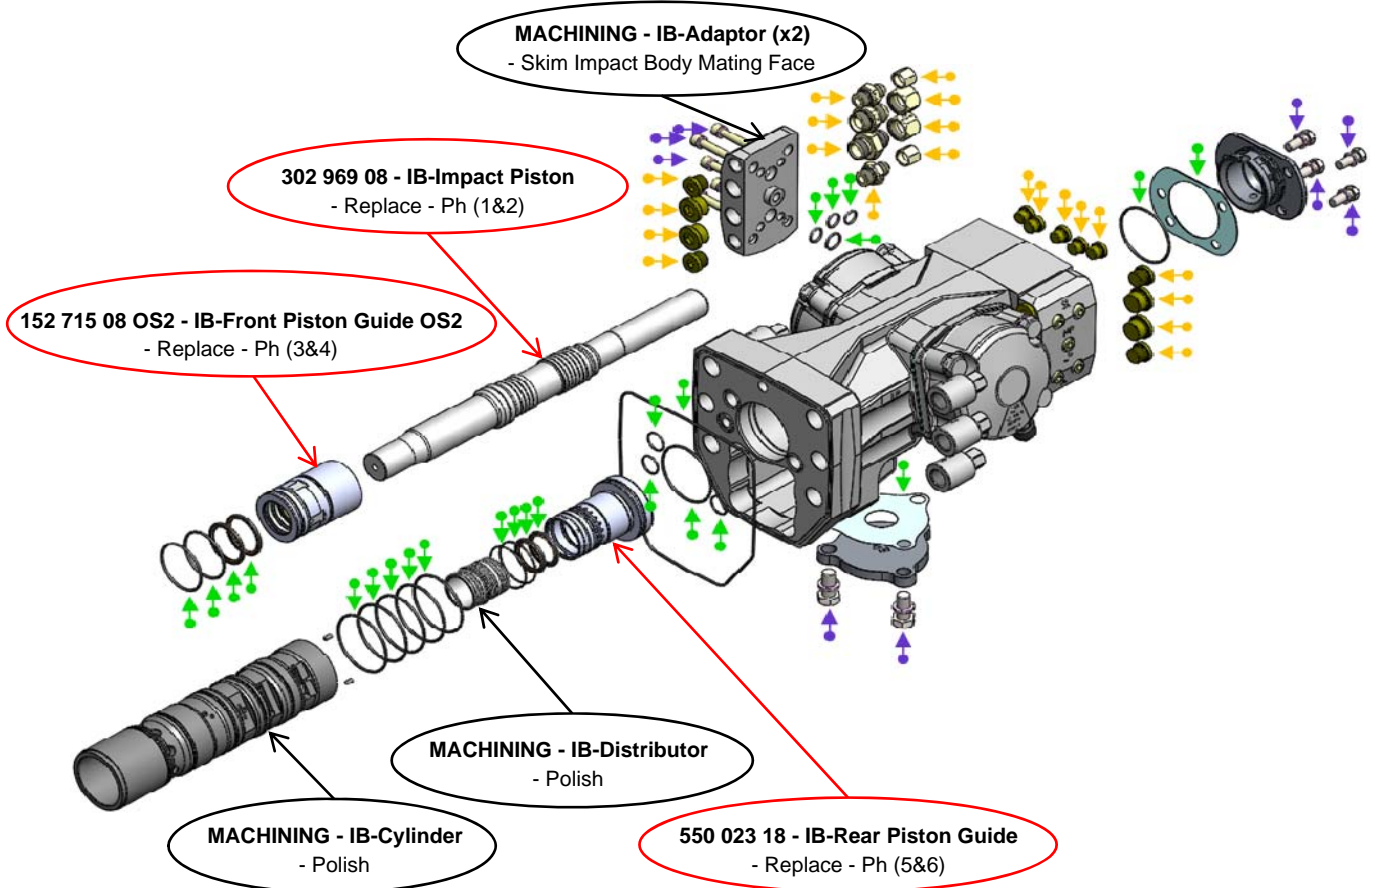
Impact Body Machining and Significant Items Replaced

Impact Body - Gear Housing, HP Accumulator and HP&LP Adaptor mating faces skimmed this service - Overall length, bore dimensions, bore condition and fatigue life have been considered when analysing the overall condition of the Impact Body. The current condition is 45% of overall life.

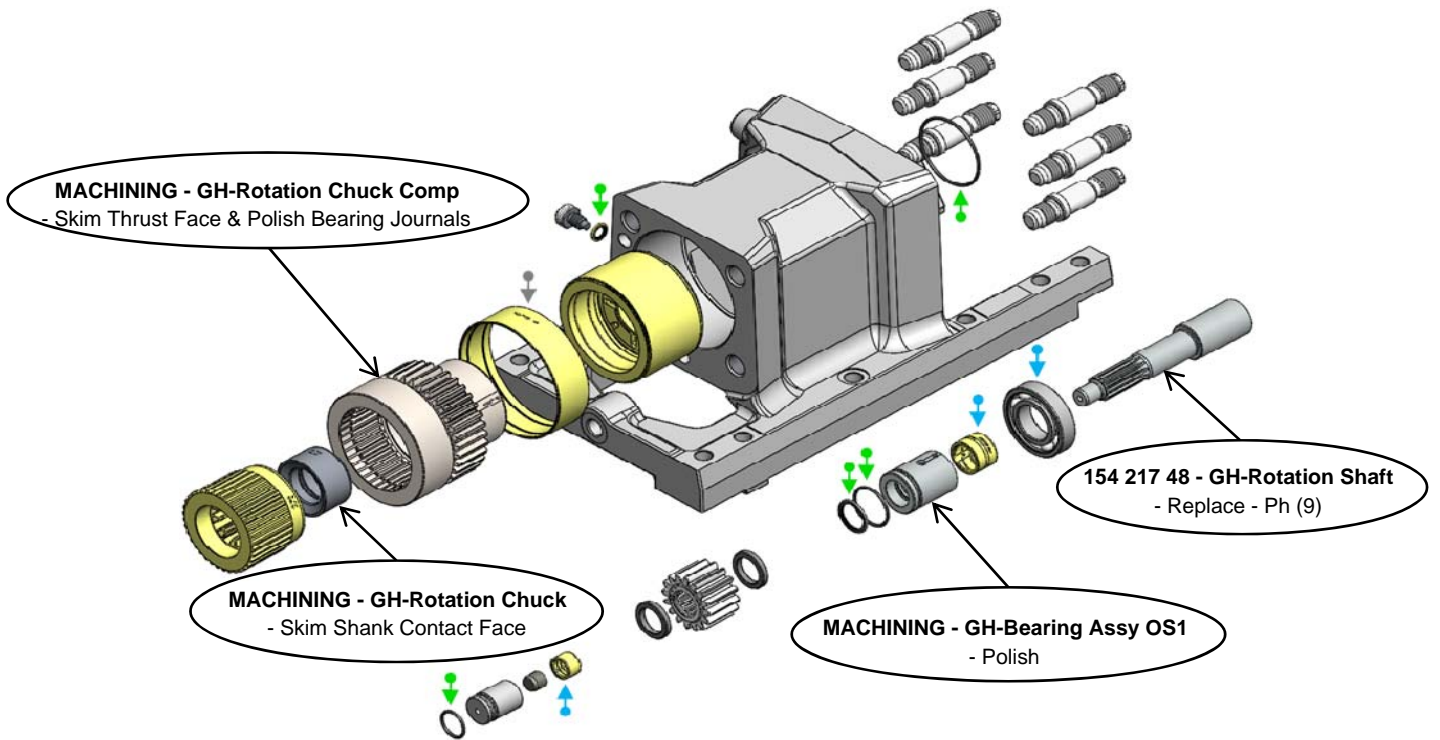
Gear Housing Machining and Significant Items Replaced

Gear Housing - Impact Piston Guide OS2 Mod, Large Ball Bearing Spigot Bore Repairs completed this service - Overall length, bore dimensions, bore condition and fatigue life have been considered when analysing the overall condition of the Gear Housing. The current condition is 40% of overall life.
