# NIFTY COPPER PTY LTD

## STRIP AND QUOTE HLX5 ROCKDRILL -

### Sandvik Mining and Construction Pty Ltd Australia

Customer: NIFTY COPPER PTY LTD Date: 09/09/2019 Job number: 7395639

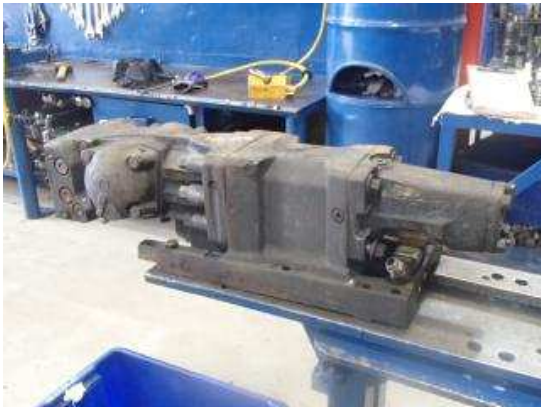
**Picture 1**

In a steel box.  
Rockdrill with complete flushing head and seal carrier.

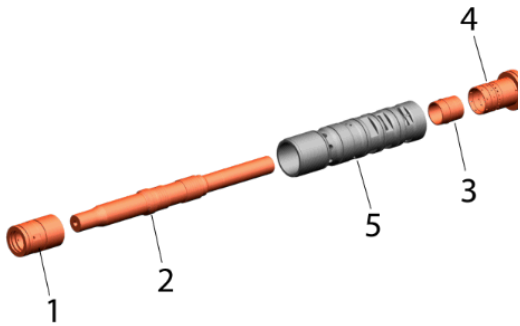
| Ref. | Part Description | Qty | Cond. code | Comment |
|---|---|---|---|---|
| 2 | PISTON - INC PERCUSSION KIT | 1 | 9 | The piston percussion seal area is scored/pitted. |

2 The piston percussion seal area is scored/pitted.

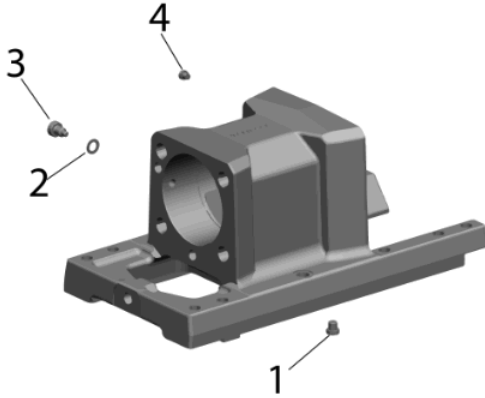
The gear case front face is unevenly worn, most likely caused by flushing housing bolts being loose at some stage. Requires skimming to square up the face and will remain within spec.

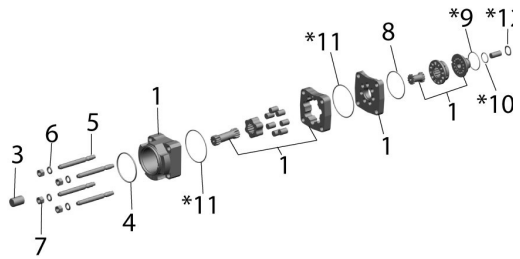
| Ref. | Part Description | Qty | Cond. code | Comment |
|---|---|---|---|--|
| 1 | MOTOR, HYDRAULIC, OMS 80/s3 | 1 | 9 | The motor internal is scored near the top end. |

1 The motor internal is scored near the top end.

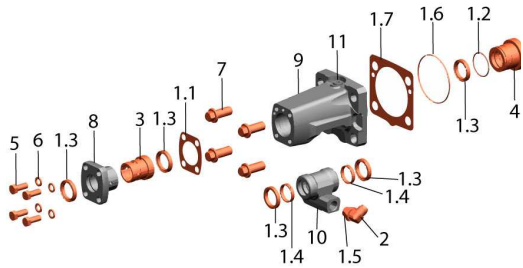
| Ref. | Part Description | Qty | Cond. code | Comment |
|---|--|---|---|--|
| 10 | HOUSING, SEAL WF D45 | 1 | 3 | The seal carrier flange bore is worn from general wear |

10 The seal carrier flange bore is worn from general wear

The flushing head requires repairs (build and machine) to the worn seal carrier land to extend its service life.  
 The mounting bolt lands are worn unevenly and need skimming to help prevent the bolts from coming loose.
