NIFTY COPPER PTY LTD

STRIP AND QUOTE HLX5T ROCKDRILL-

Sandvik Mining and Rock Technology Pty Ltd Australia

Customer: NIFTY COPPER PTY LTD Date: 02/04/2019 Job number: 7389399

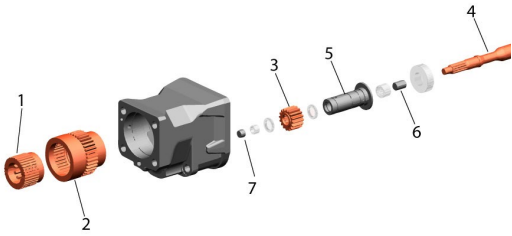
ROTATION KIT WF

Ref.	Part Description	Qty	Failure code	Comment
1	COUPLING - INC ROTATION KIT	1	3	The coupling outer splines are worn past service limit.
5	HOUSING, BEARING	1	3	The bearing housing is worn where the thrust washer contact.

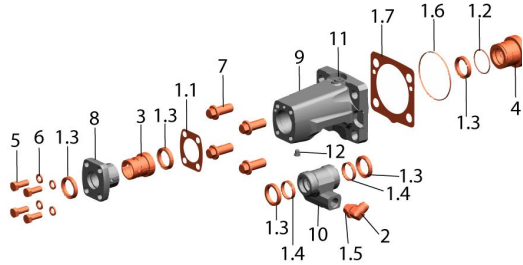
FLUSHING KIT D45

Ref.	Part Description	Qty	Failure code	Comment
*	FLUSHING HEAD REBUILD KIT - INCLUDES BG0800869	1	1	
3	BUSHING, BEARING	0	3	The front cover bush is worn.
4	BUSHING, SHANK	0	3	The rear shank bush striker face is pitted and starting to crack.

Endurance kit and Flushing head kit.

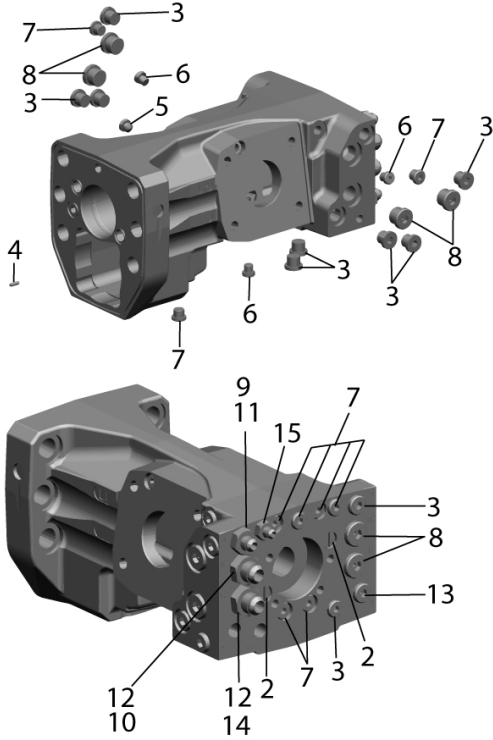
FRAME ASSEMBLY

Ref.	Part Description	Qty	Failure code	Comment
2	PLUG	2	1	
3	PLUG	11	1	
7	PLUG	9	1	
8	PLUG	6	1	
9	STRAIGHT THREAD ADAPTER	3	1	
10	STRAIGHT THREAD ADAPTER	1	1	
11	PLUG	3	1	
12	PLUG	2	1	
14	ORIFICE ADAPTER	1	1
