#### 2010 Atlas Copco COP1838 Incomplete with Parts AVO10D605E

Service Report

Drill Assessed: COP 1838 MUX - AVO 10D 605E

#### Independence (Long) COP 1838 MUX SN AVO 10D 605E Service Report - Build 2

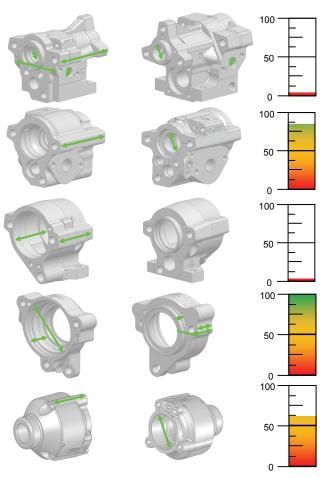
#### **Housing Body Condition**

**Impact Housing -** Hone Bore this service - Overall length, bore dimensions, bore condition and fatigue life have been considered when analysing the overall condition of the Impact Housing. On Condition.

**Damping Housing -** No work required this service - Overall length, bore dimensions, bore condition and fatigue life have been considered when analysing the overall condition of the Damping Housing. The current condition is 85% of overall life.

**Gear Housing -** No work required this service -Overall length, bore dimensions, bore condition and fatigue life have been considered when analysing the overall condition of the Gear Housing. On Condition..

**Cover Plate -** No work required this service -Overall length, bore dimensions, bore condition and fatigue life have been considered when analysing the overall condition of the Cover Plate. The current condition is 100% of overall life.

**MUX Head - IND 061683 -** No work required this service - Overall length, bore dimensions, bore condition and fatigue life have been considered when analysing the overall condition of the MUX Head. The current condition is 60% of overall life.

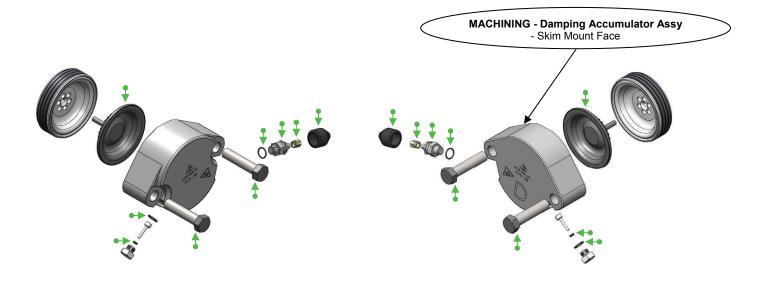
#### **Accumulator Assemblies Machining and Significant Items Replaced**

Ph (6) - LP Accumulator - Reference - Damaged diaphragm

Ph (7) - LP Accumulator - Reference - Damaged diaphragm.

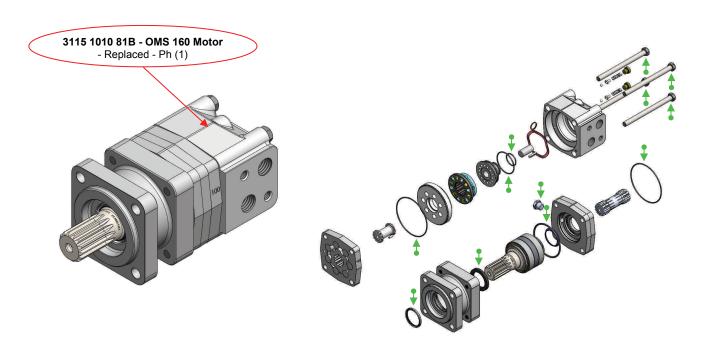
#### **Hydraulic Motor Machining and Significant Items Replaced**

**Ph (1) - OMS 160 Motor** - Replaced - Scored on gerola mating face .
