# NIFTY COPPER PTY LTD

## STRIP AND QUOTE HLX5T ROCKDRILL

### Sandvik Mining and Construction Pty Ltd Australia

Customer: NIFTY COPPER PTY LTD Date: 09/07/2019 Job number: 7393445

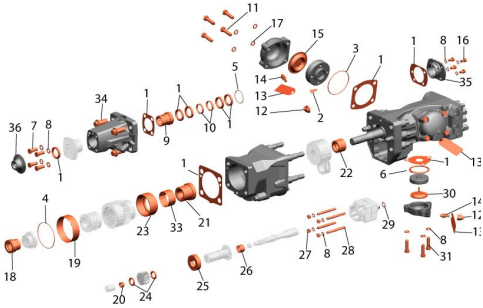
Upon dismantling the percussion circuit was found water contaminated which has most likely occurred only recently/shortly before removal as there is minimal evidence of subsequent damage or increased wear rates.

Water contaminated percussion circuit.

Investigate source of water contamination, check oil coolers etc.

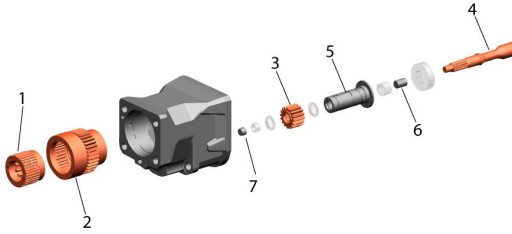
Ref.	Part Description	Qty	Cond. code	Comment
1	COUPLING - INC ROTATION KIT	1	3	The coupling is worn near to service limit at the internal splines.
4	SHAFT, ROTATING - INC ROTATION KIT	1	3	The rotation shaft has worn at the seal journal, spigot bearing journal and internal splines.

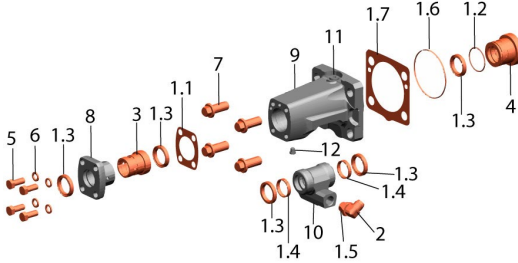
\* The shank bush is worn to limit at the striker face but included in the flushing head rebuild kit.
